An industrial hygiene investigation was conducted on July 7, 23, and 30, 2014 by the Bergen County Department of Health Services at the following facility:

**Dumont Borough Hall**  
**50 Washington Avenue**  
**Dumont, NJ 07628**

## DUMONT BOROUGH HALL

Prepared By: County of Bergen  
Department of Health Services  
Melissa Johnson, MS, Industrial Hygienist

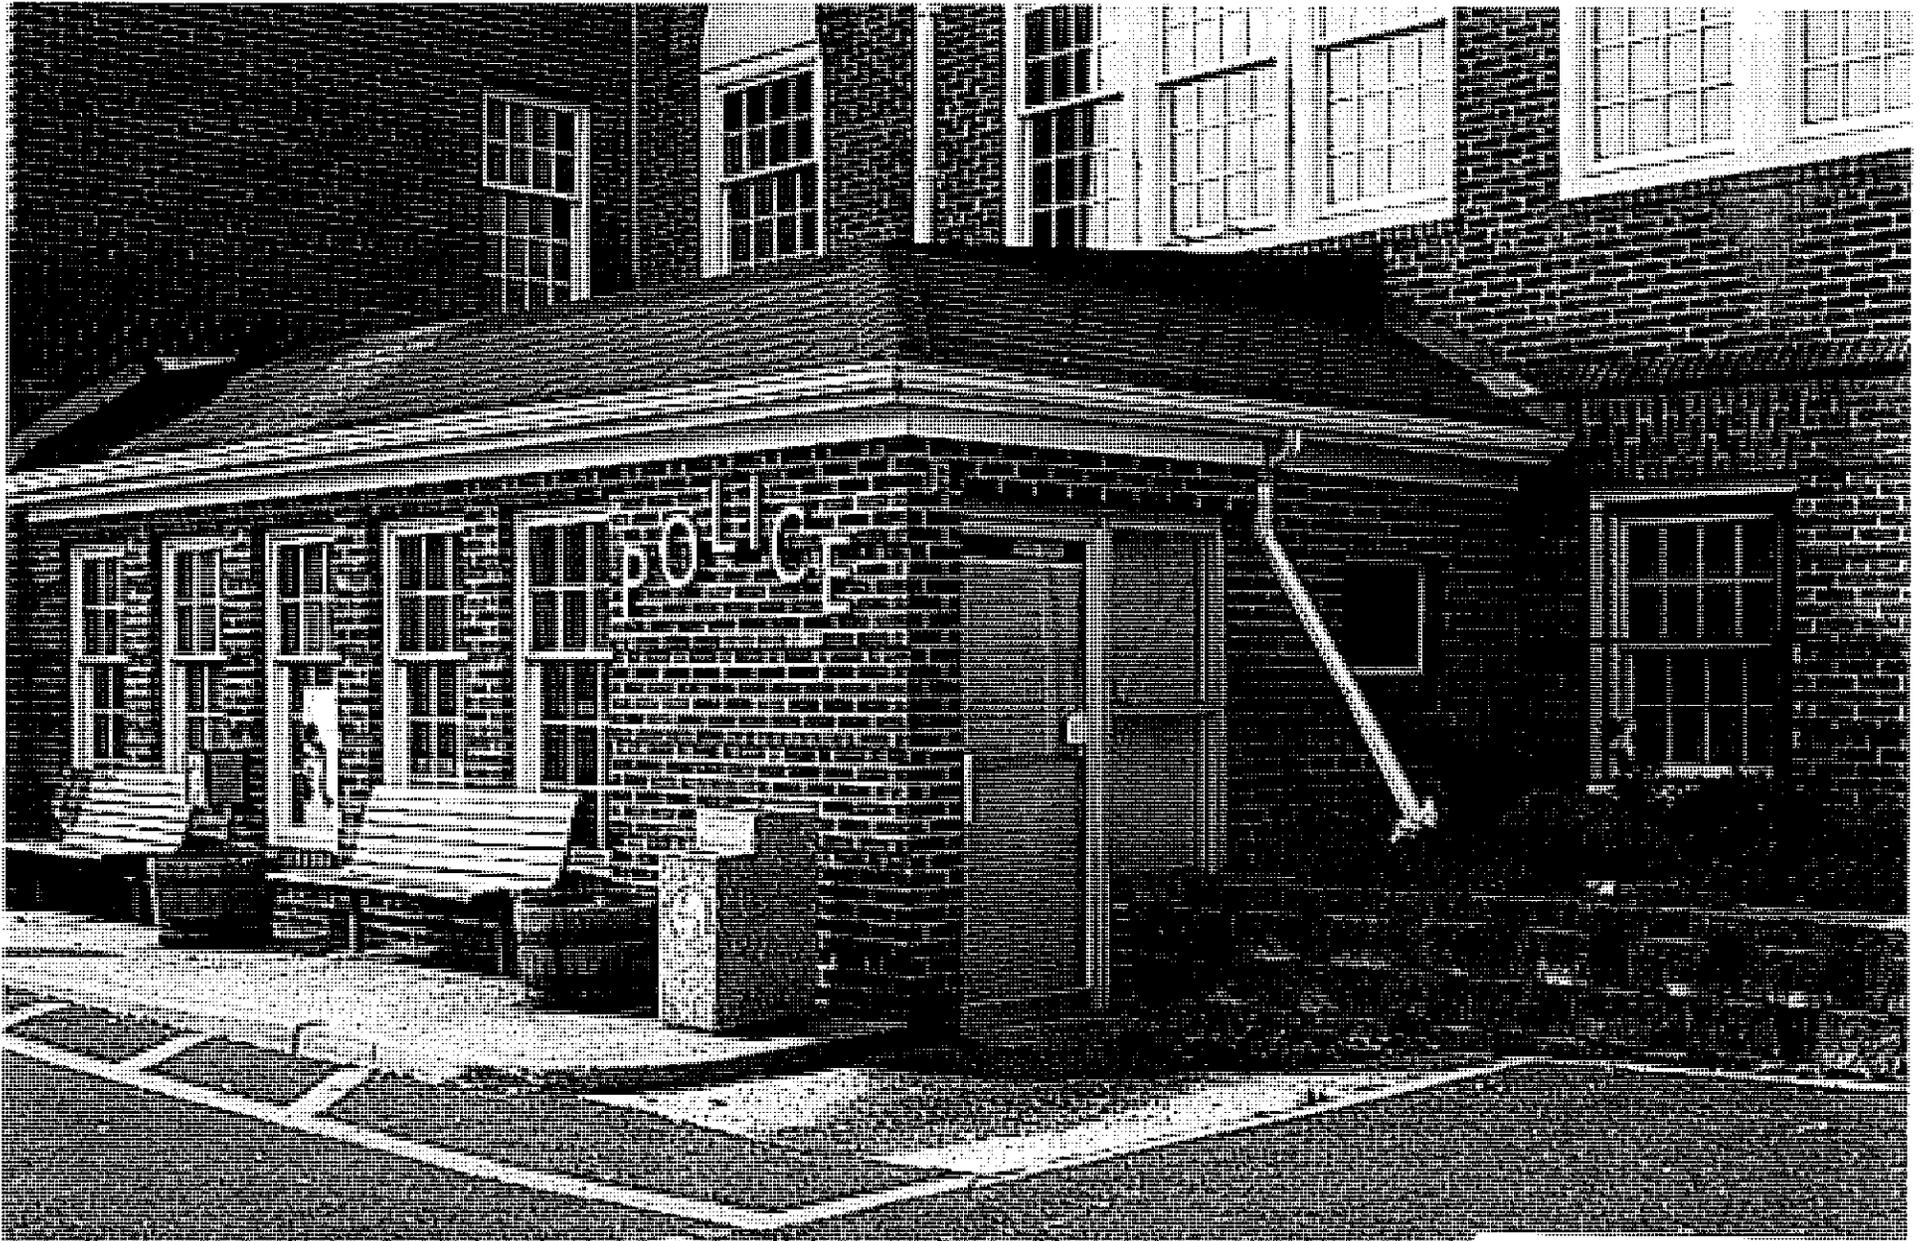
Leader from gutter-old drain clogged.  
Downspout leader pulled away from  
building to keep water away.

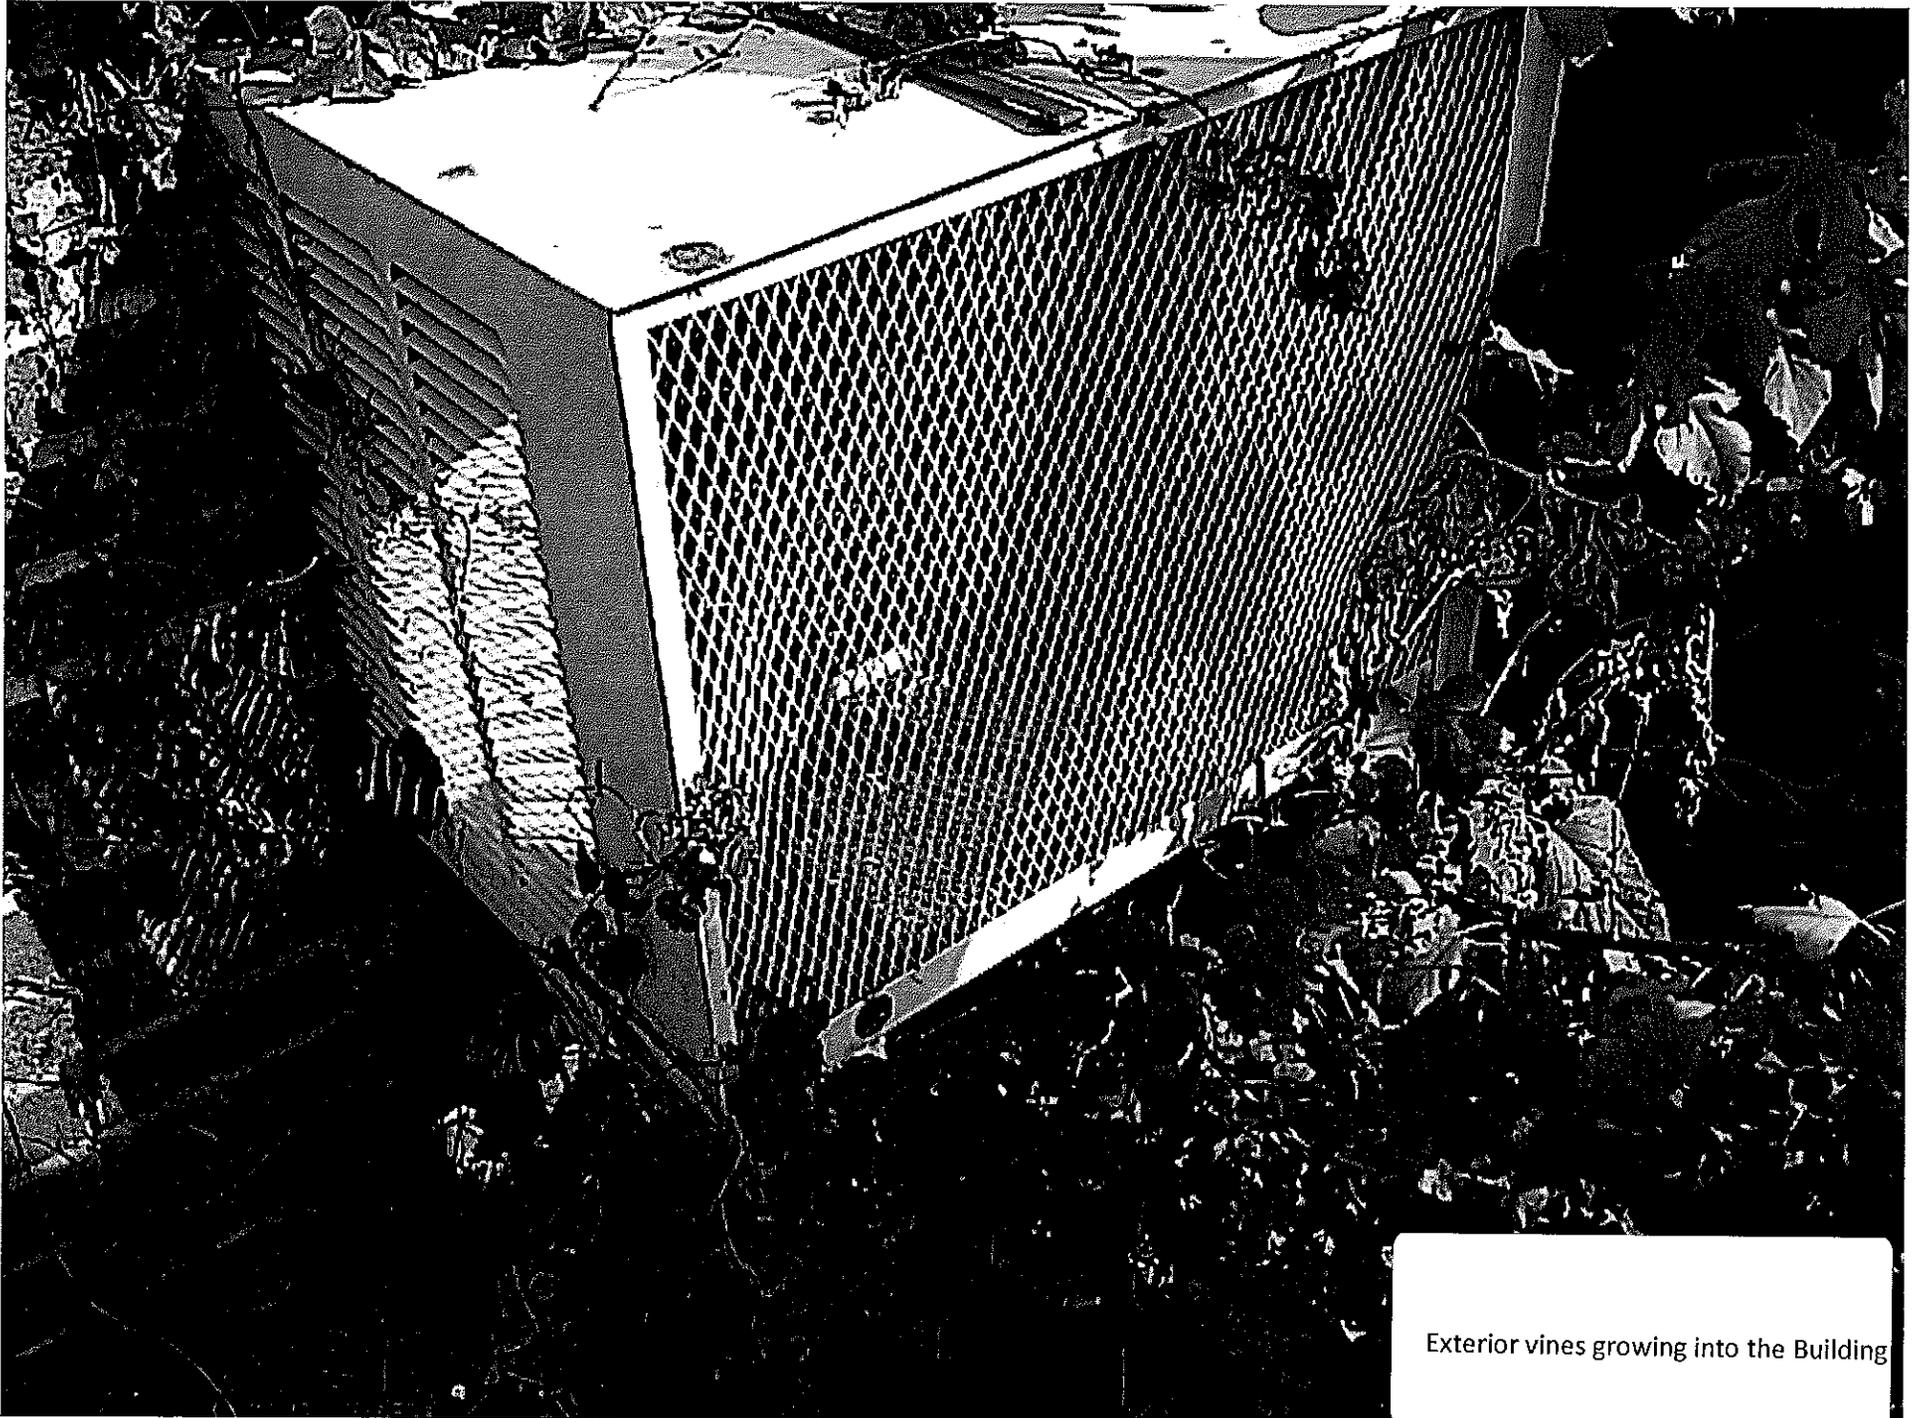
Exterior vines growing into the Building

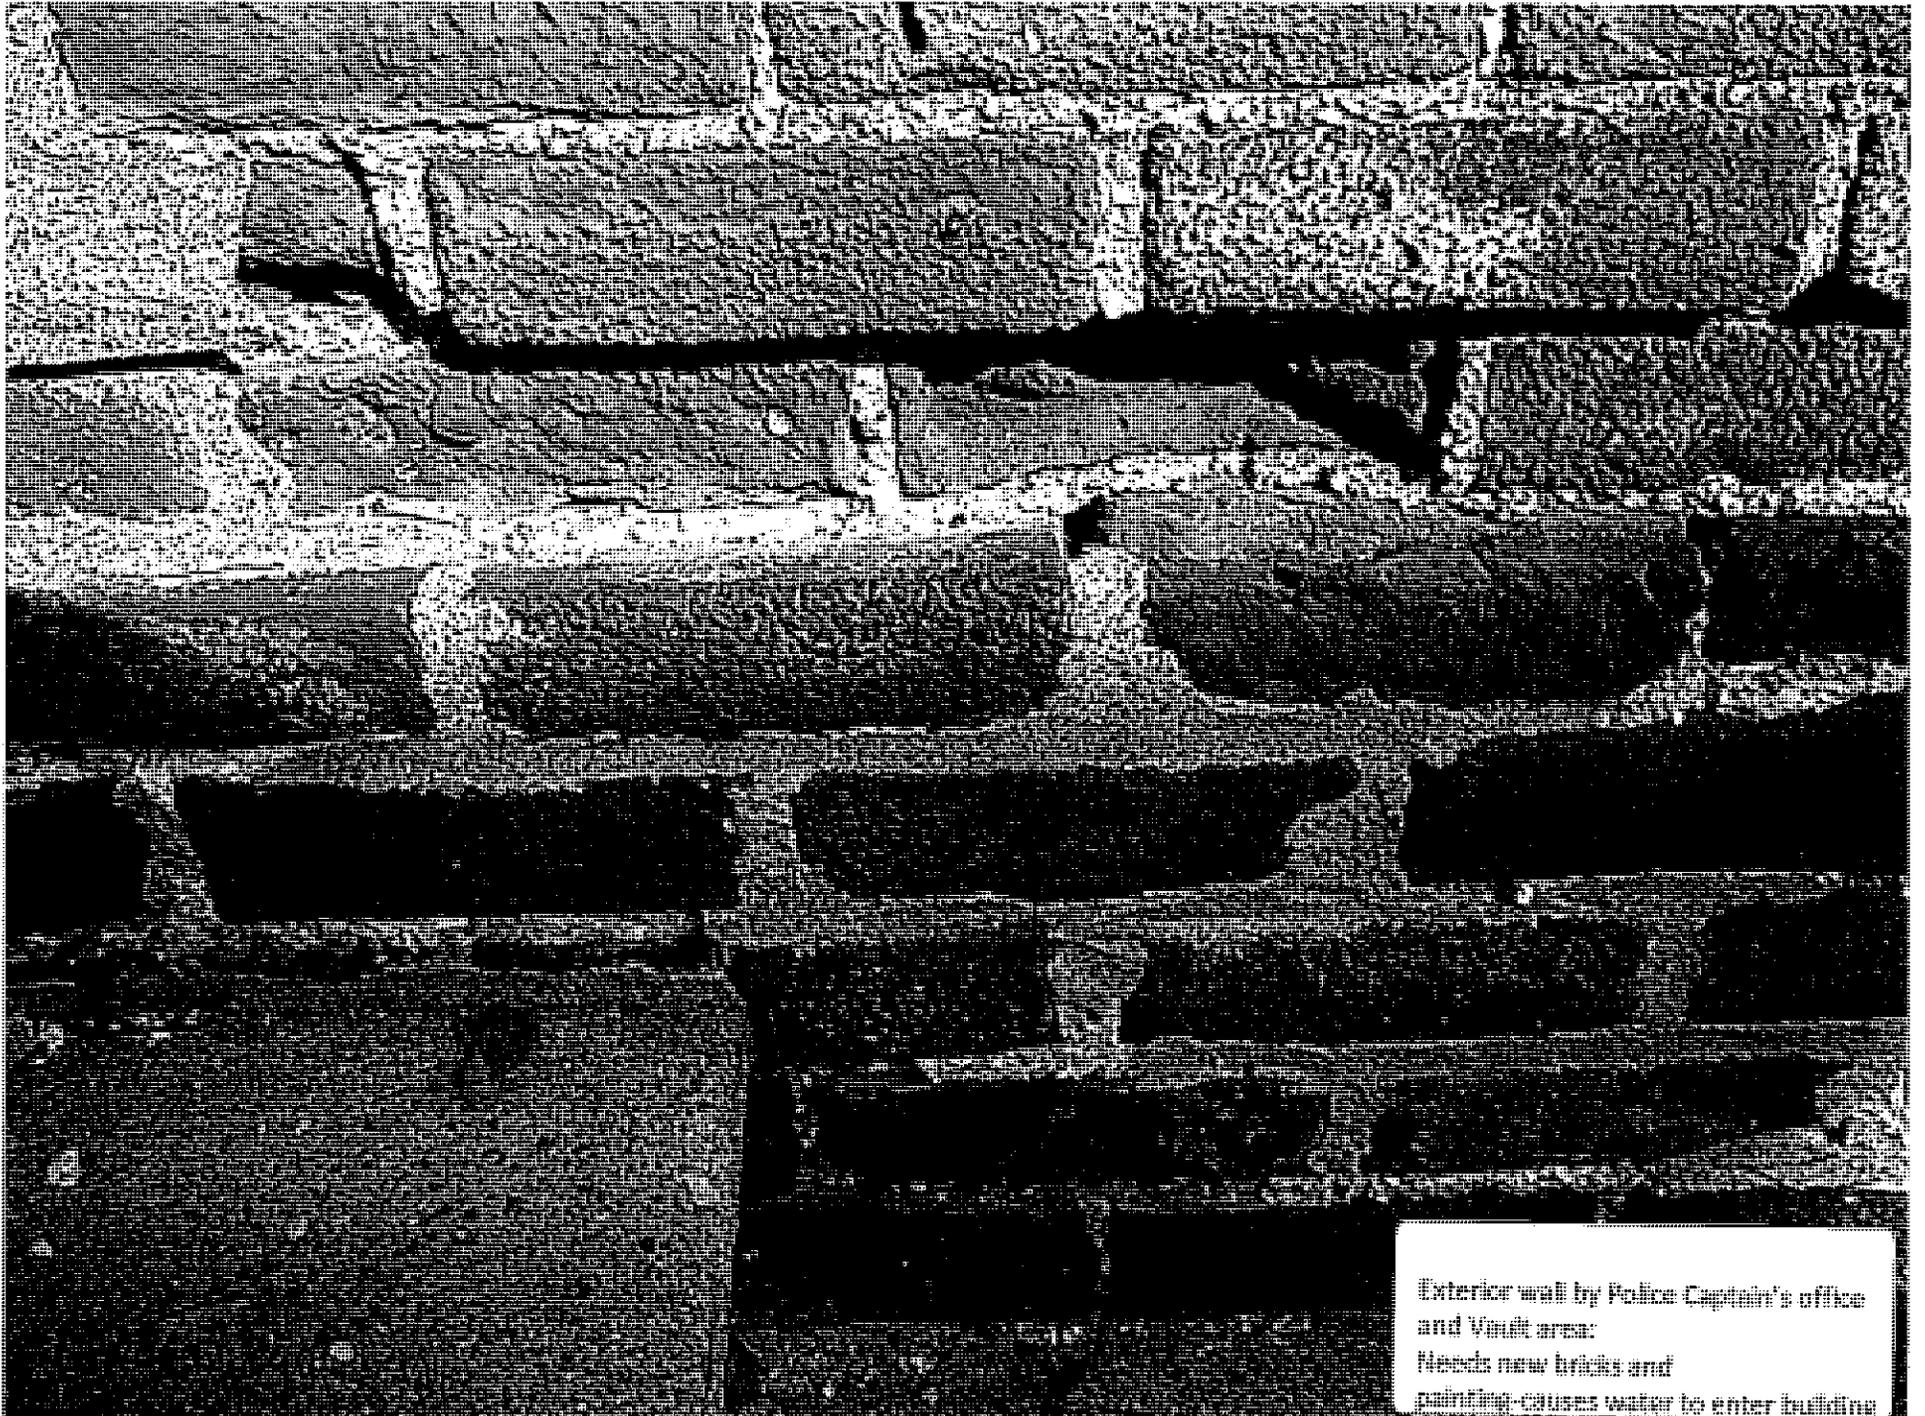
Exterior wall by Police Captain's office  
and Vault area:  
Needs new bricks and  
painting-causes water to enter building

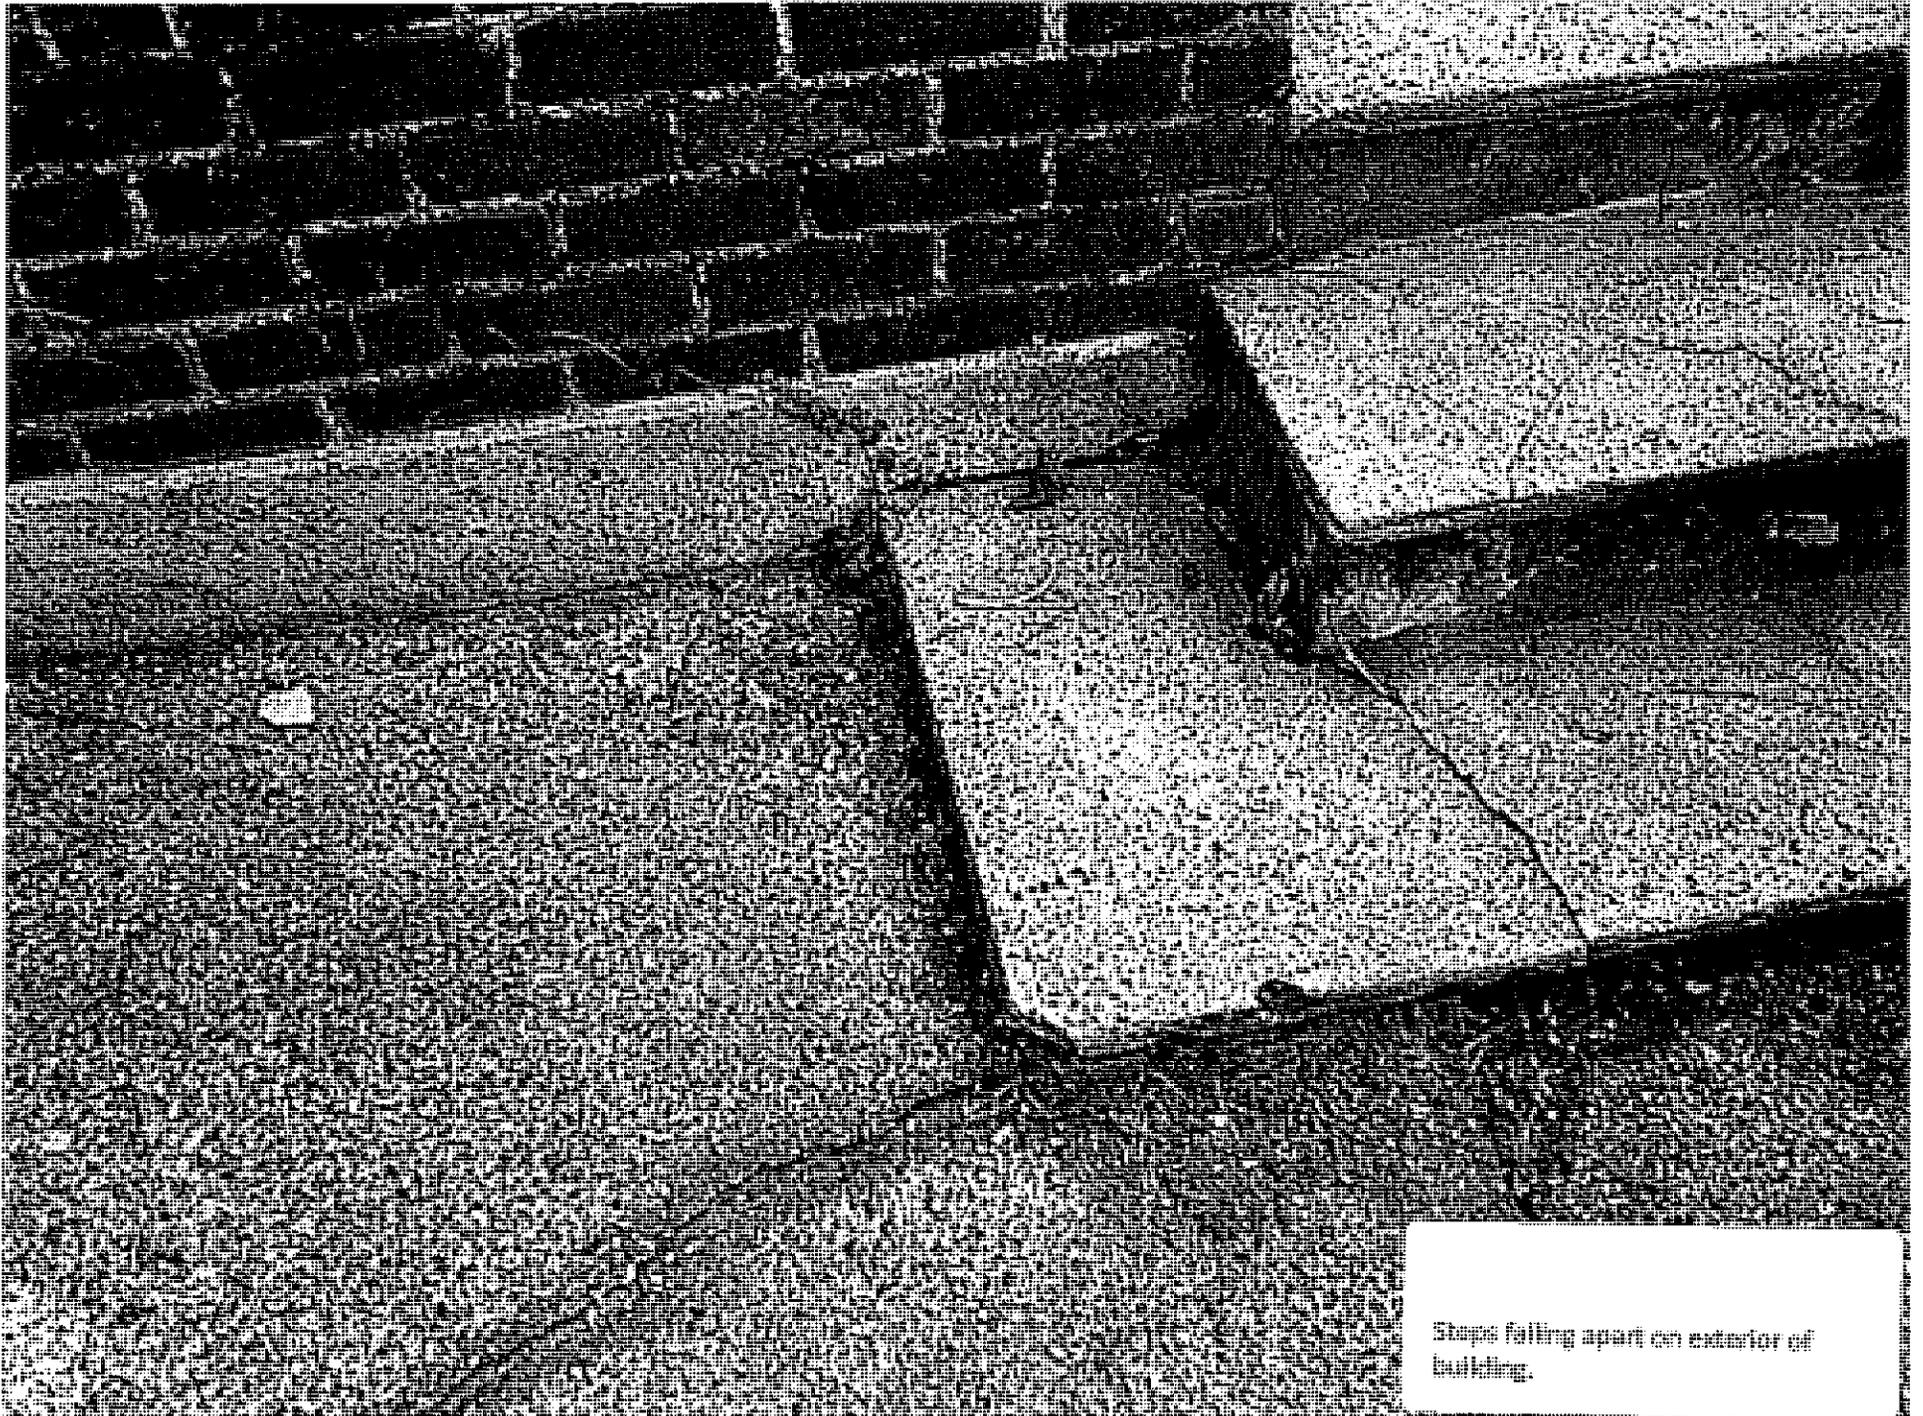
Steps falling apart on exterior of building.

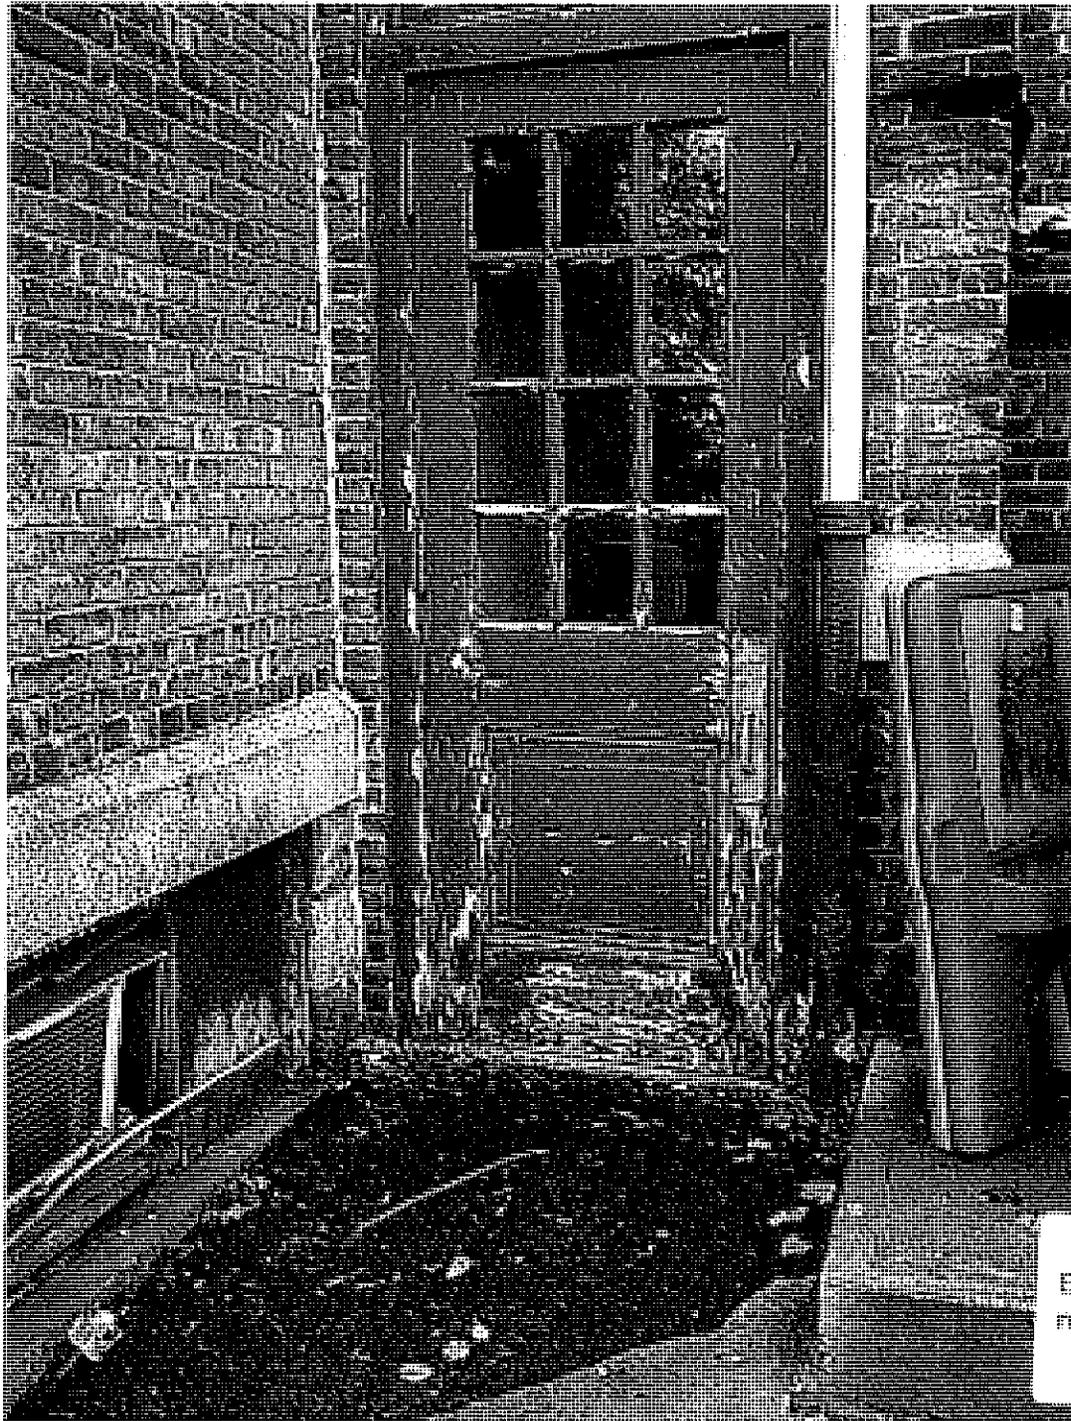
Exterior door beyond repair -  
ratted away.

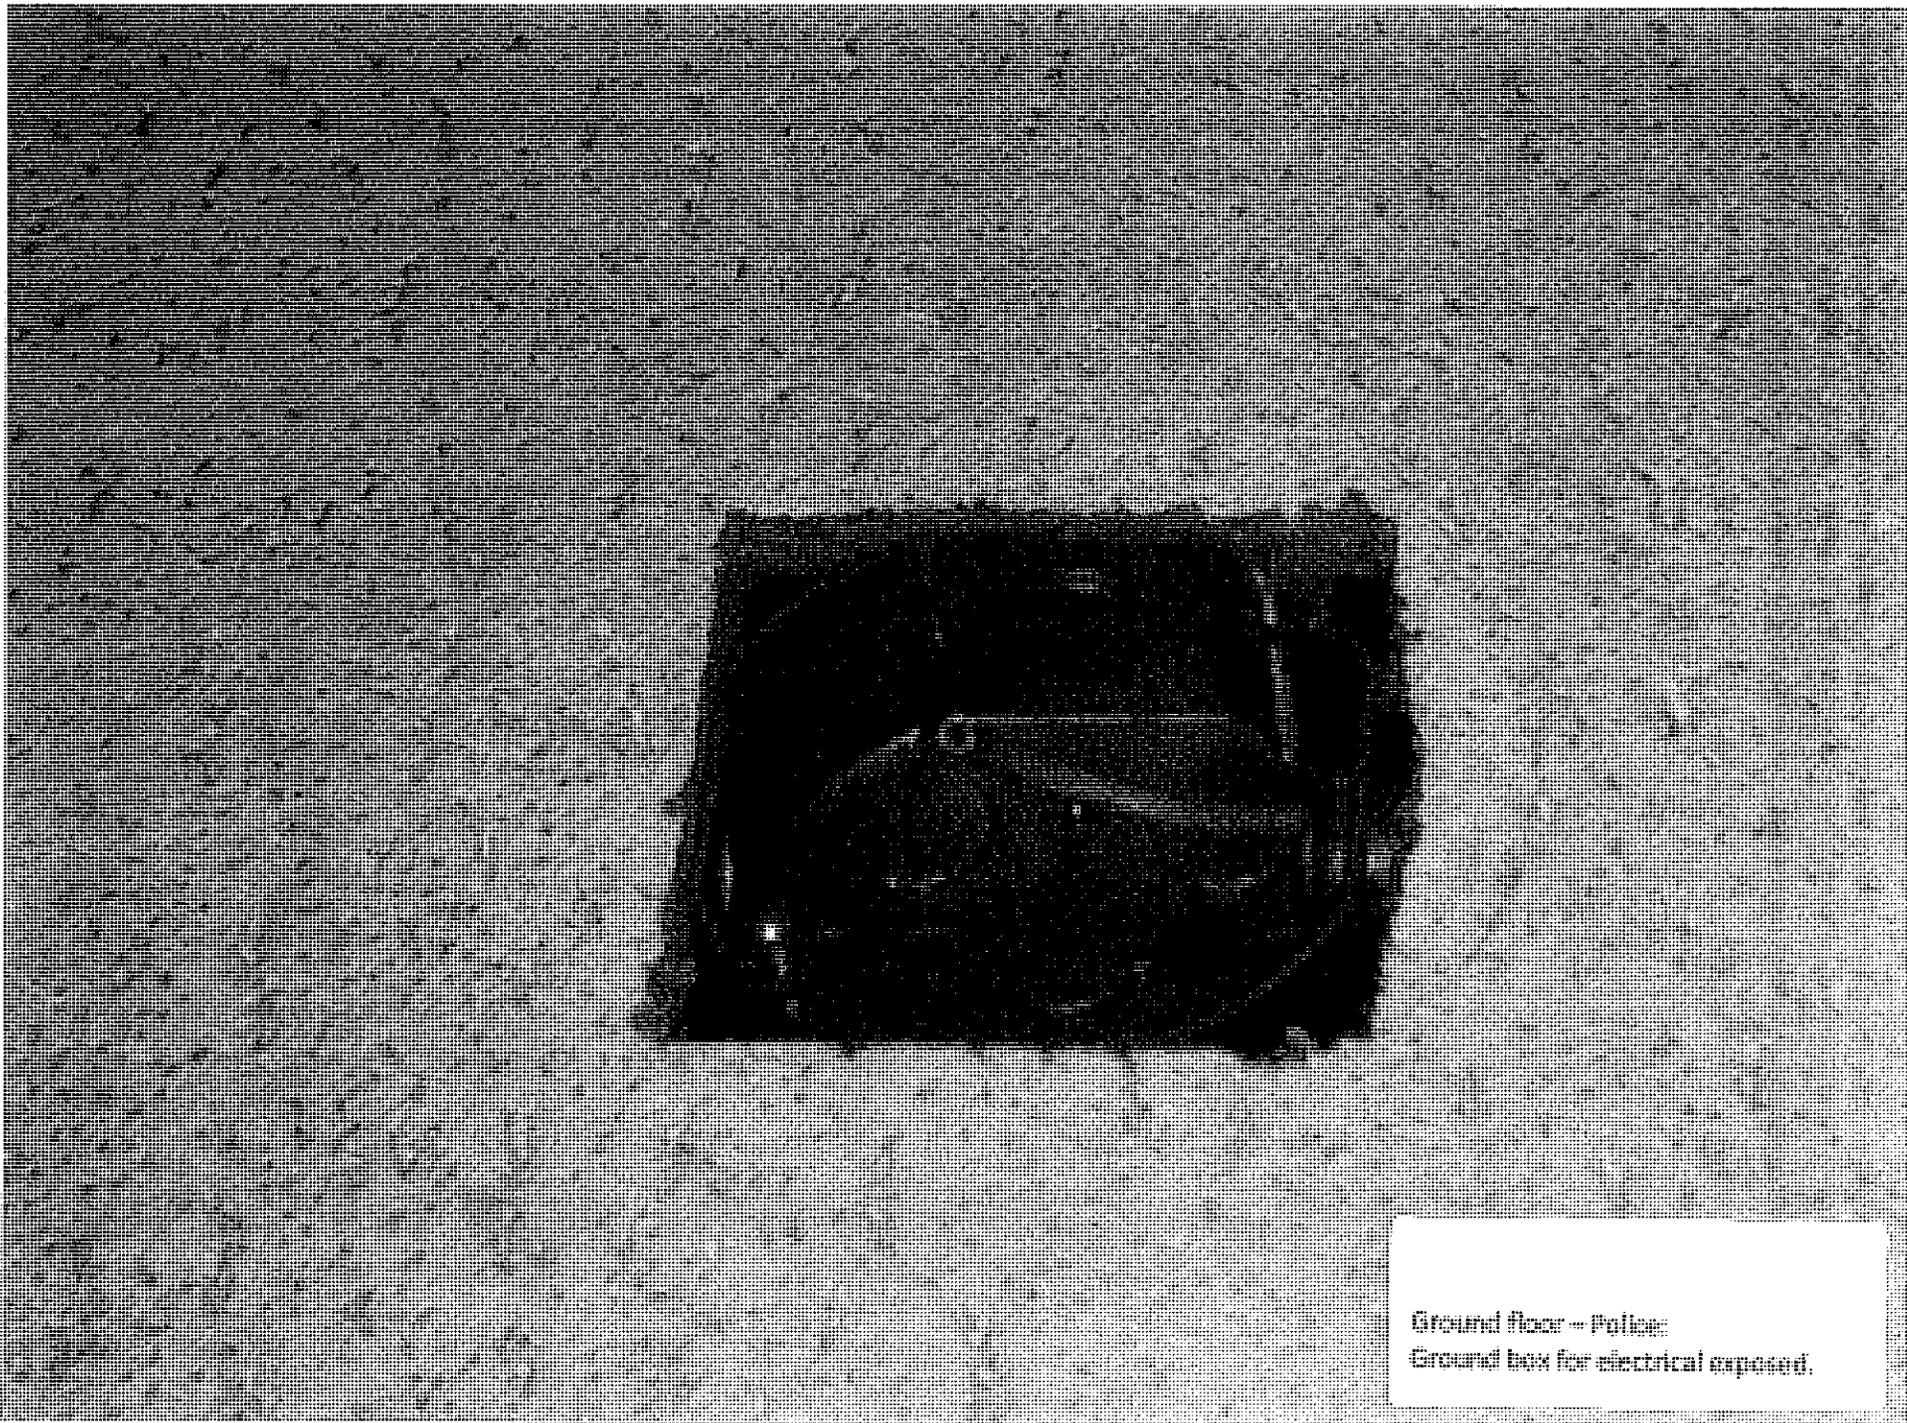
Ground floor - Police:  
Ground box for electrical exposed.

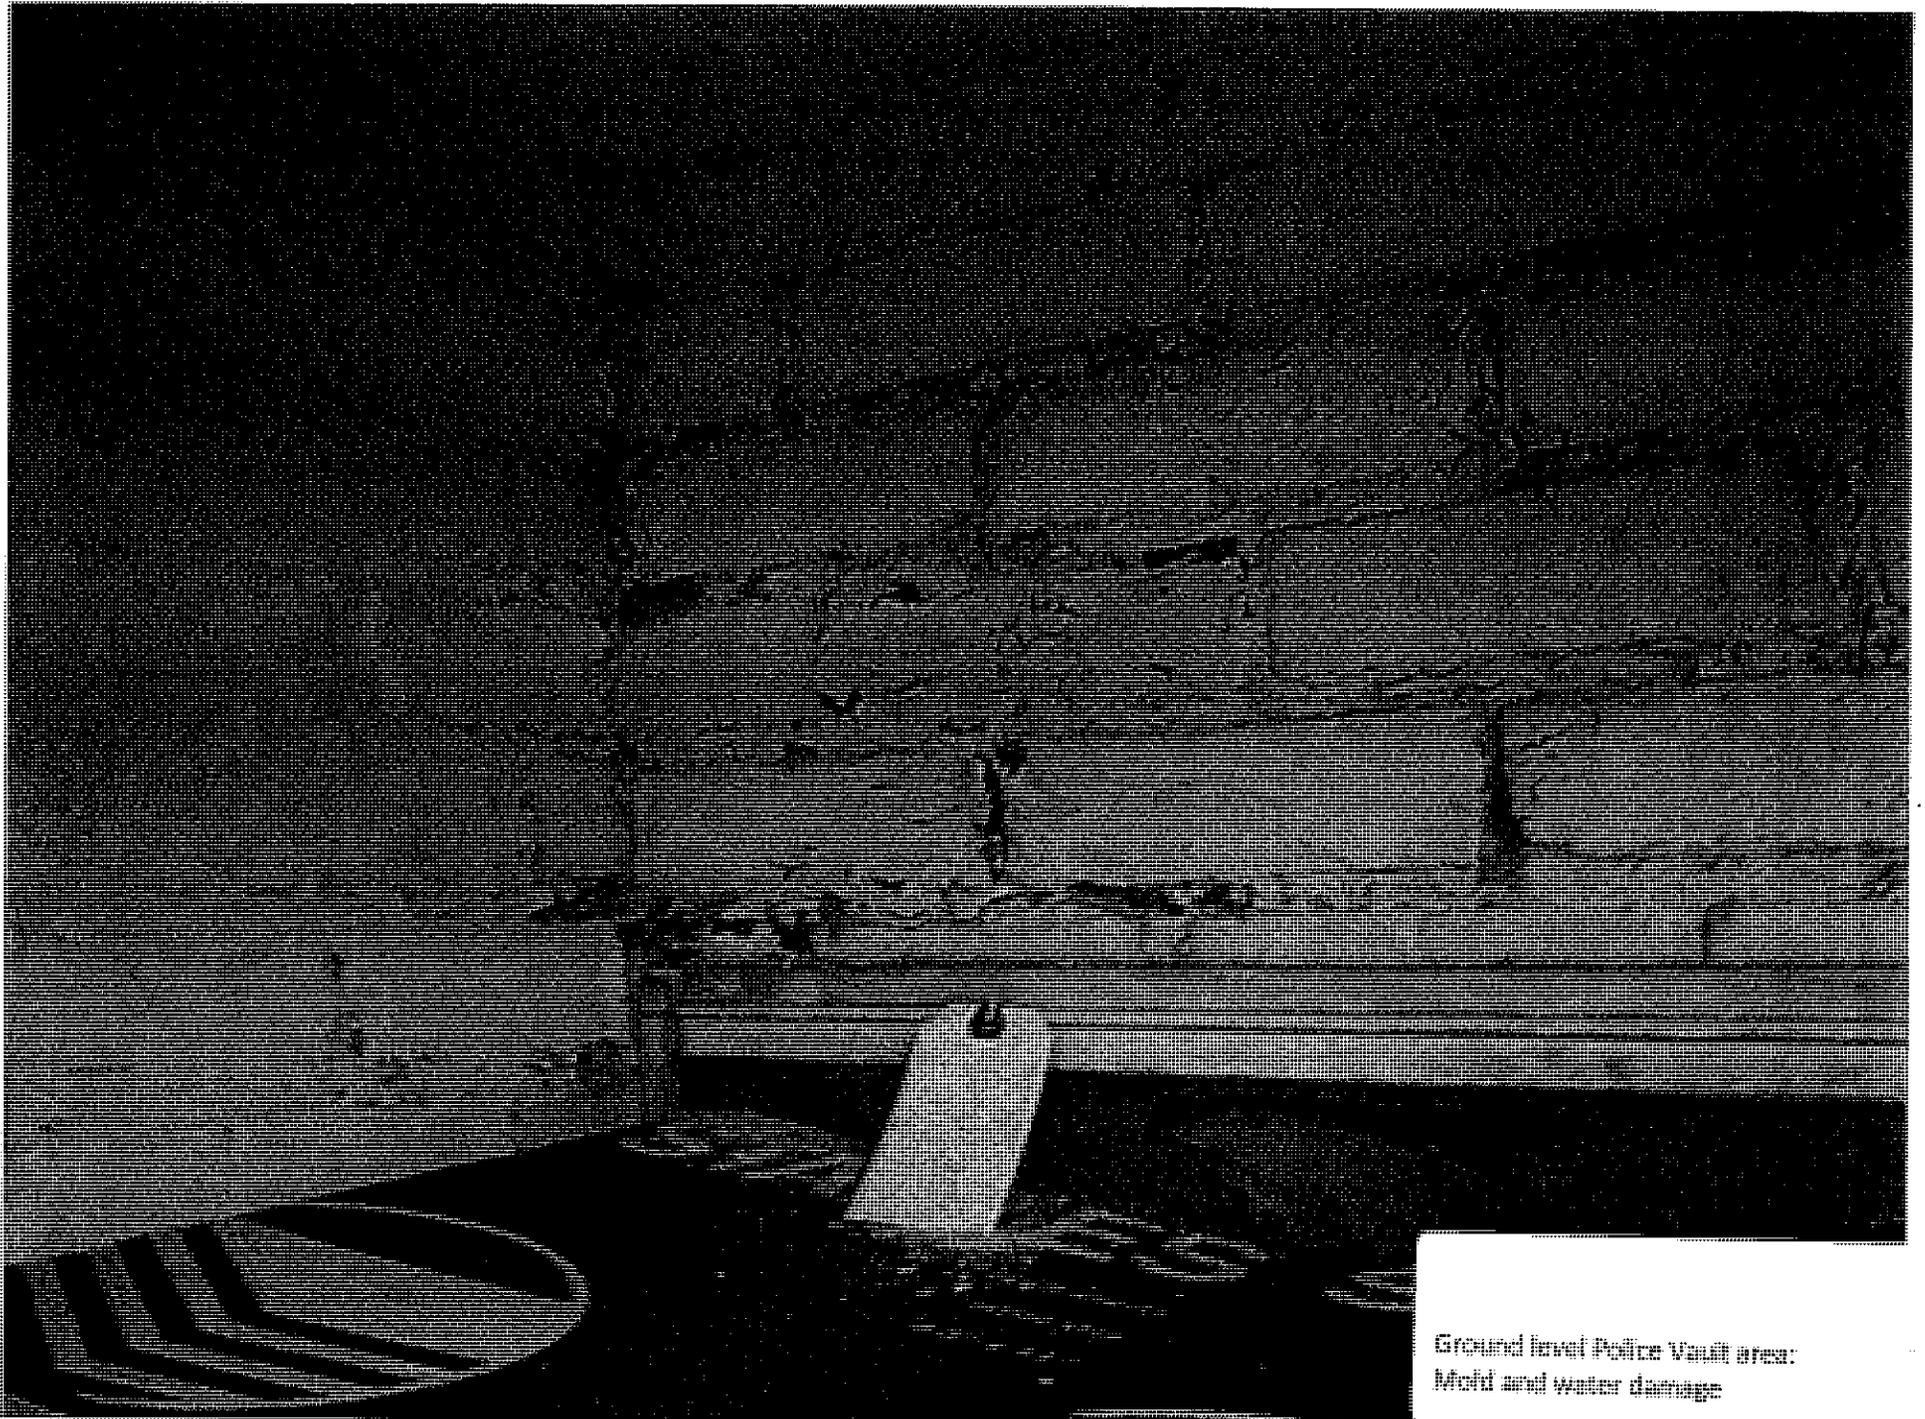
Ground level Police Vault area:  
Mold and water damage

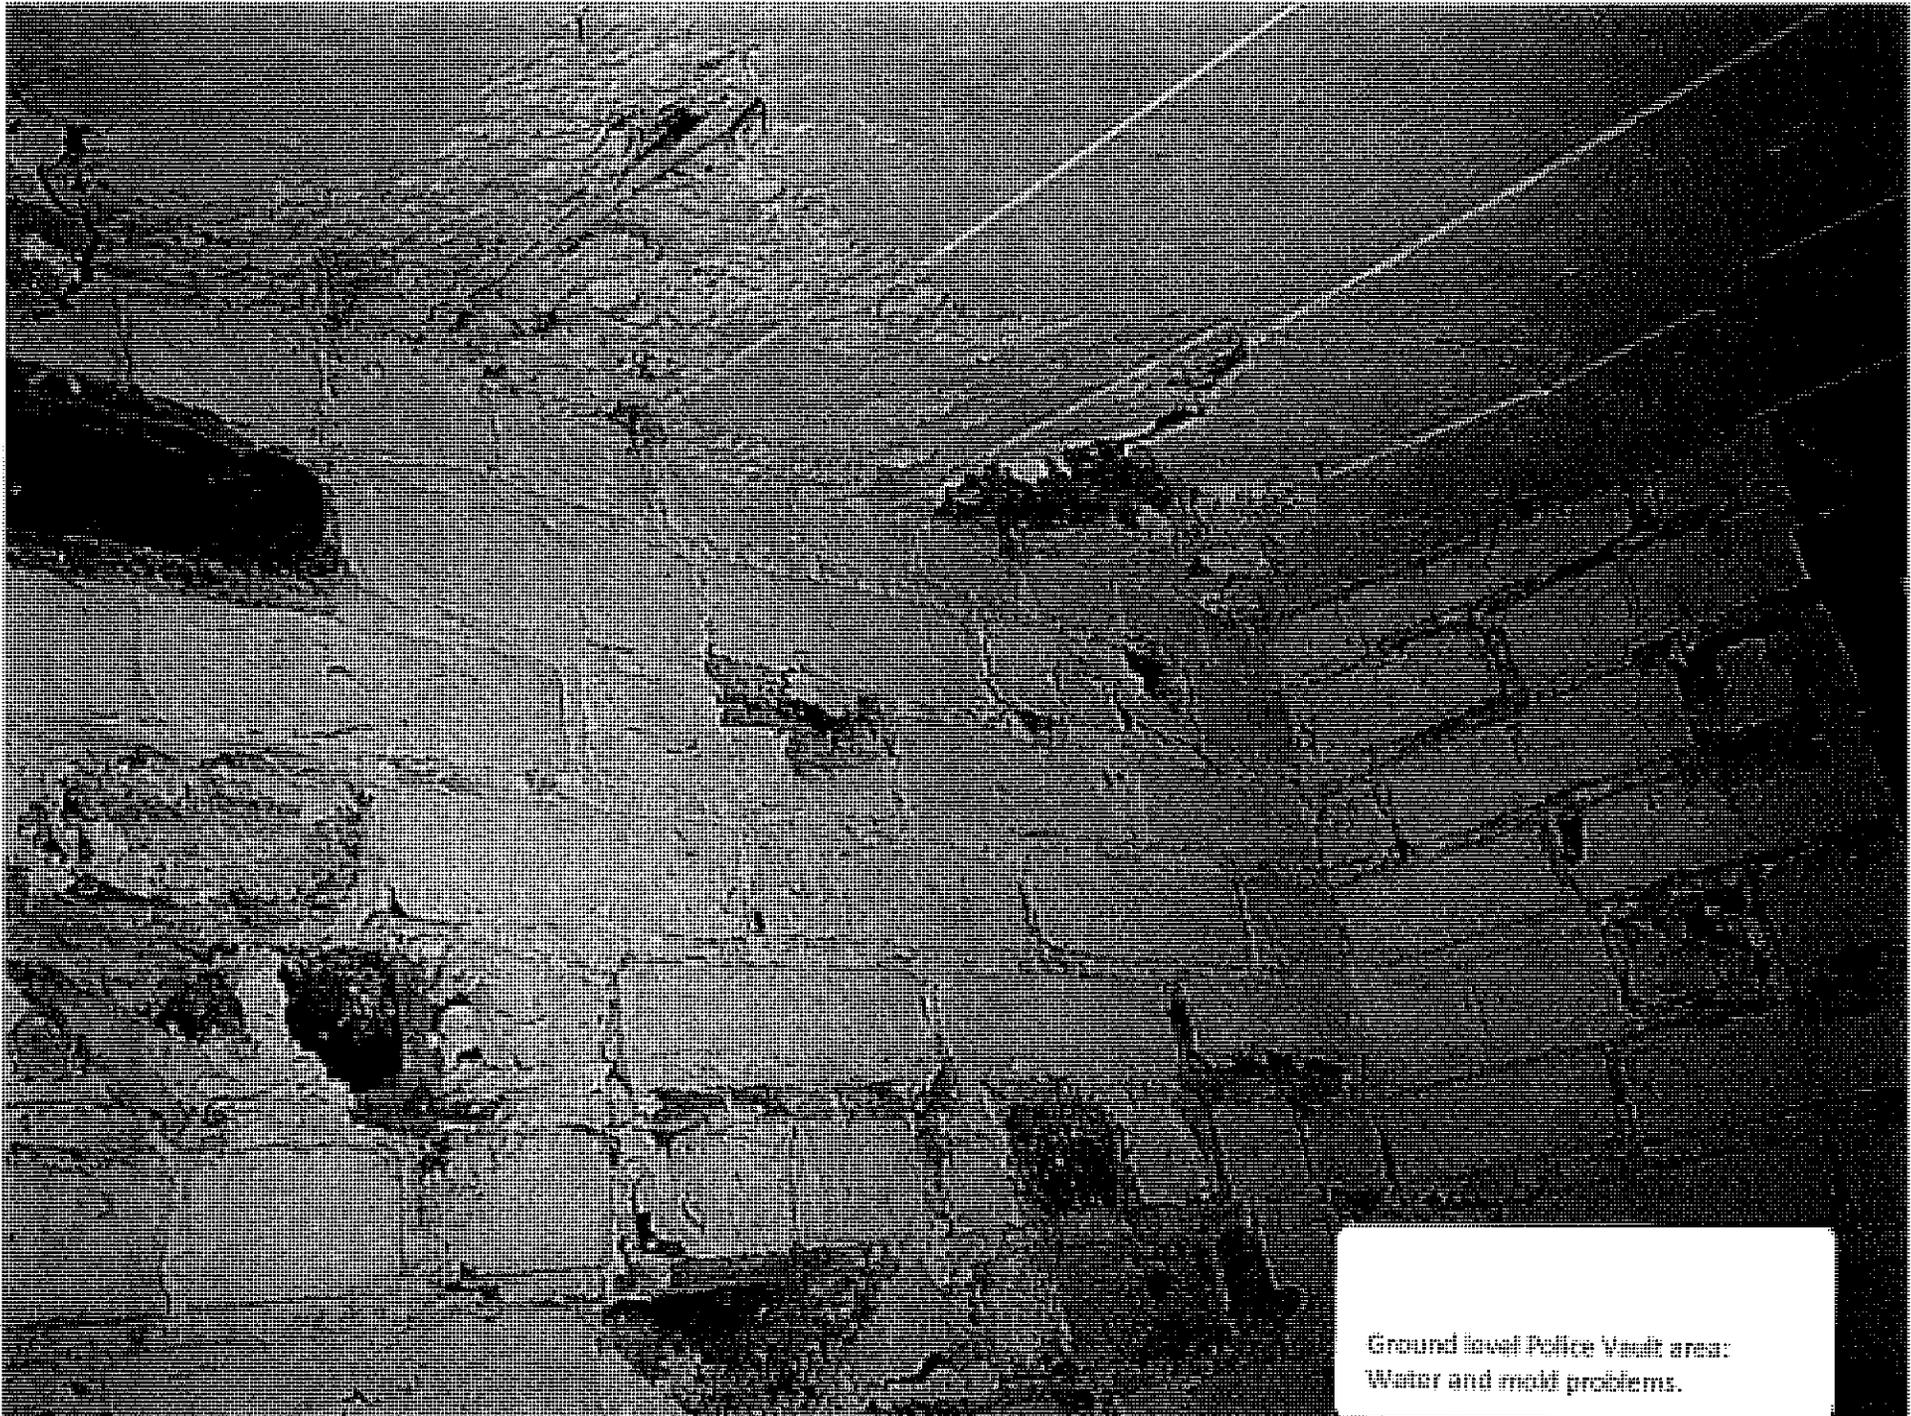
Ground level Police Vault area:  
Water and mold problems.

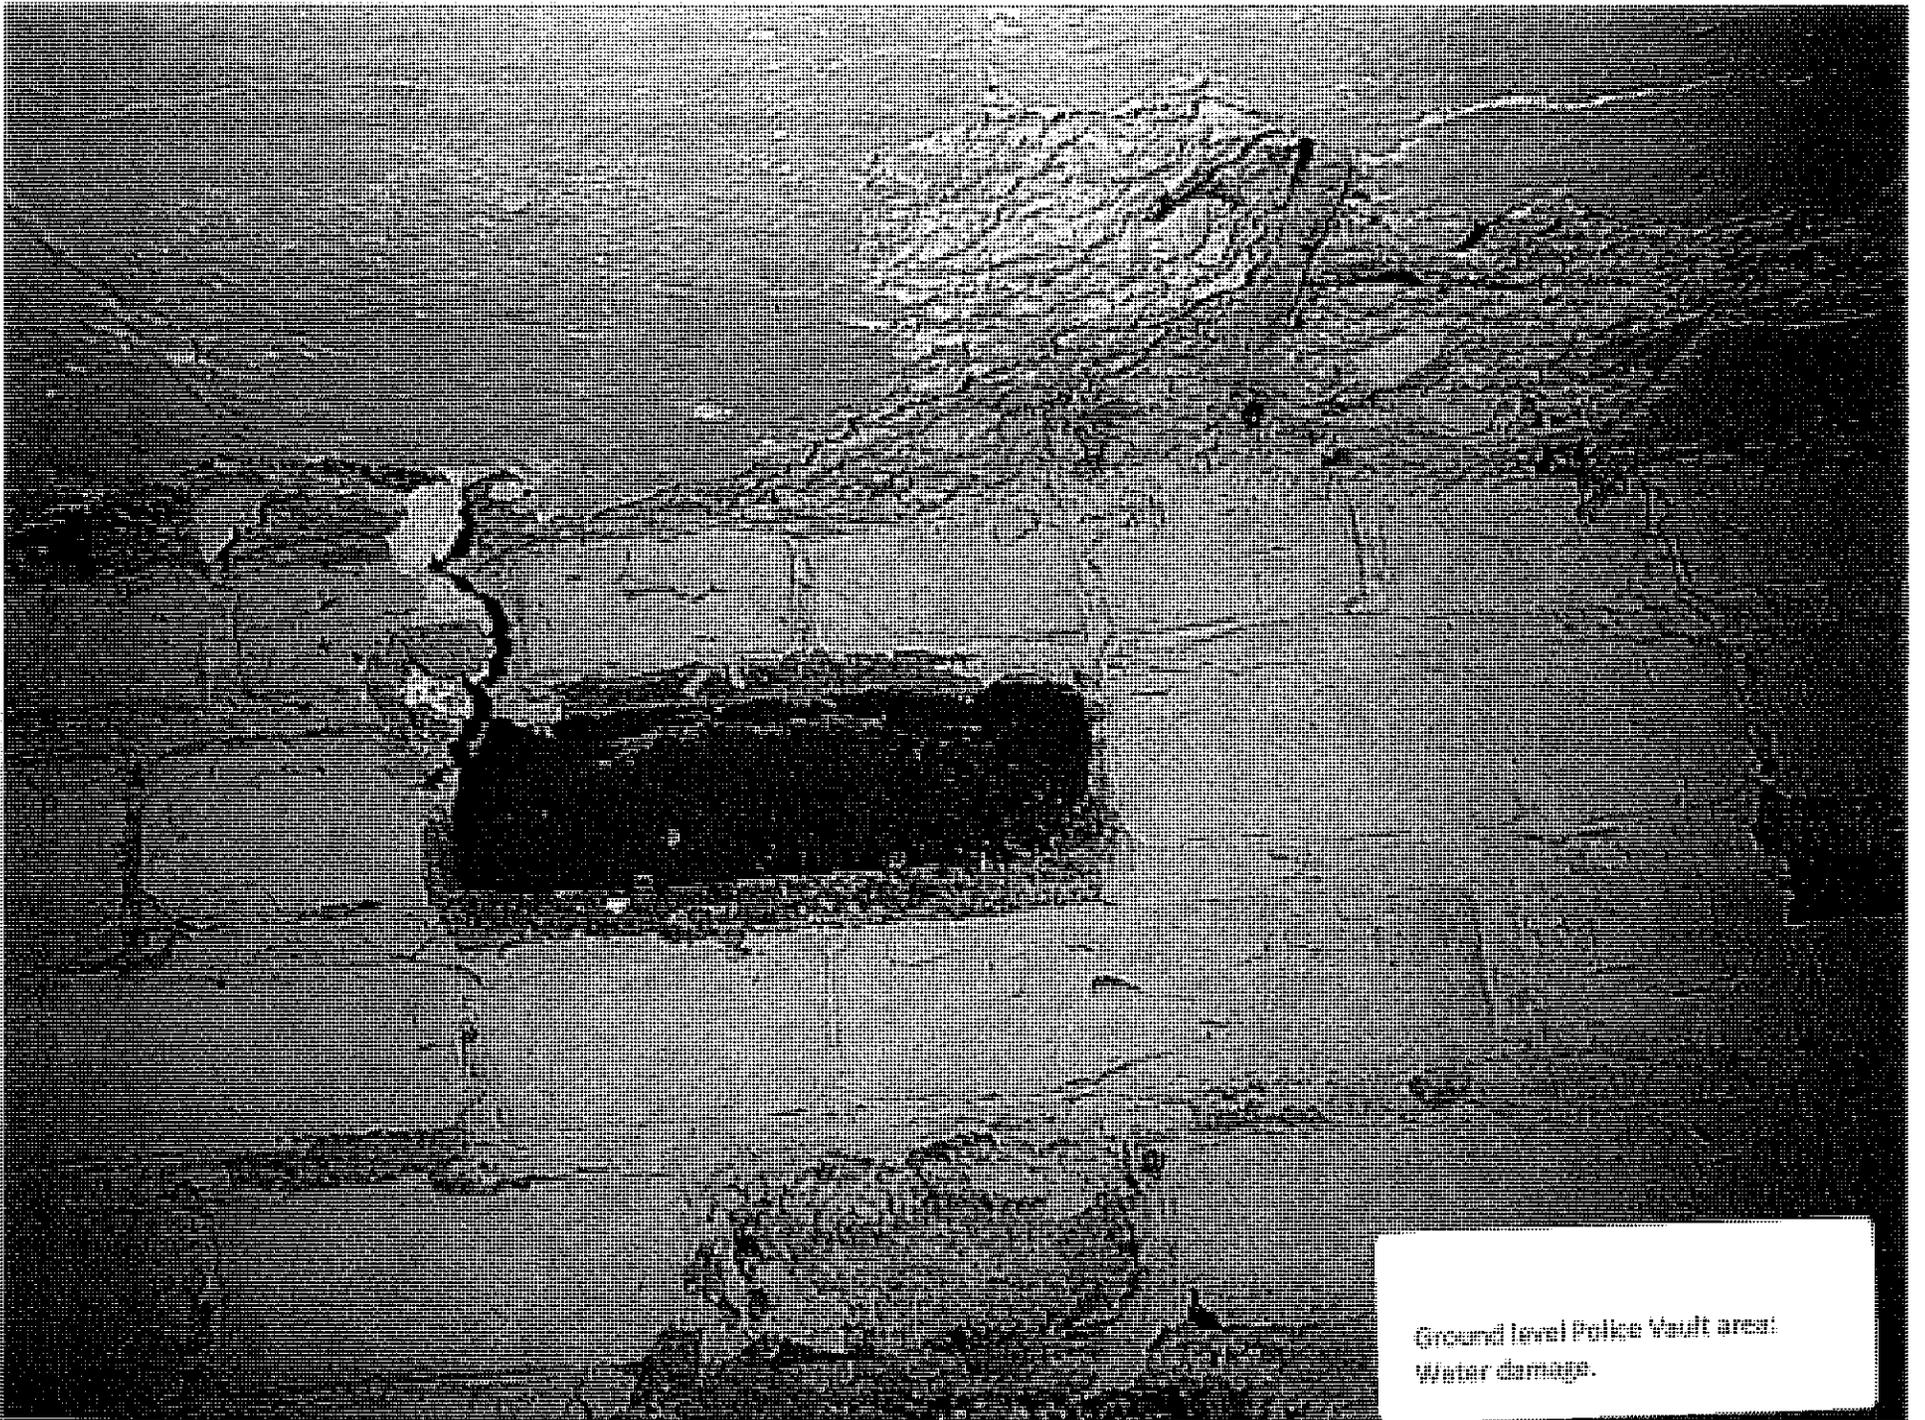
Ground level Police Vault area:  
Water damage.
