An industrial hygiene investigation was conducted on July 7, 23, and 30, 2014 by the Bergen County Department of Health Services at the following facility:

**Dumont Borough Hall**  
**50 Washington Avenue**  
**Dumont, NJ 07628**

## DUMONT BOROUGH HALL

Prepared By: County of Bergen  
Department of Health Services  
Melissa Johnson, MS, Industrial Hygienist

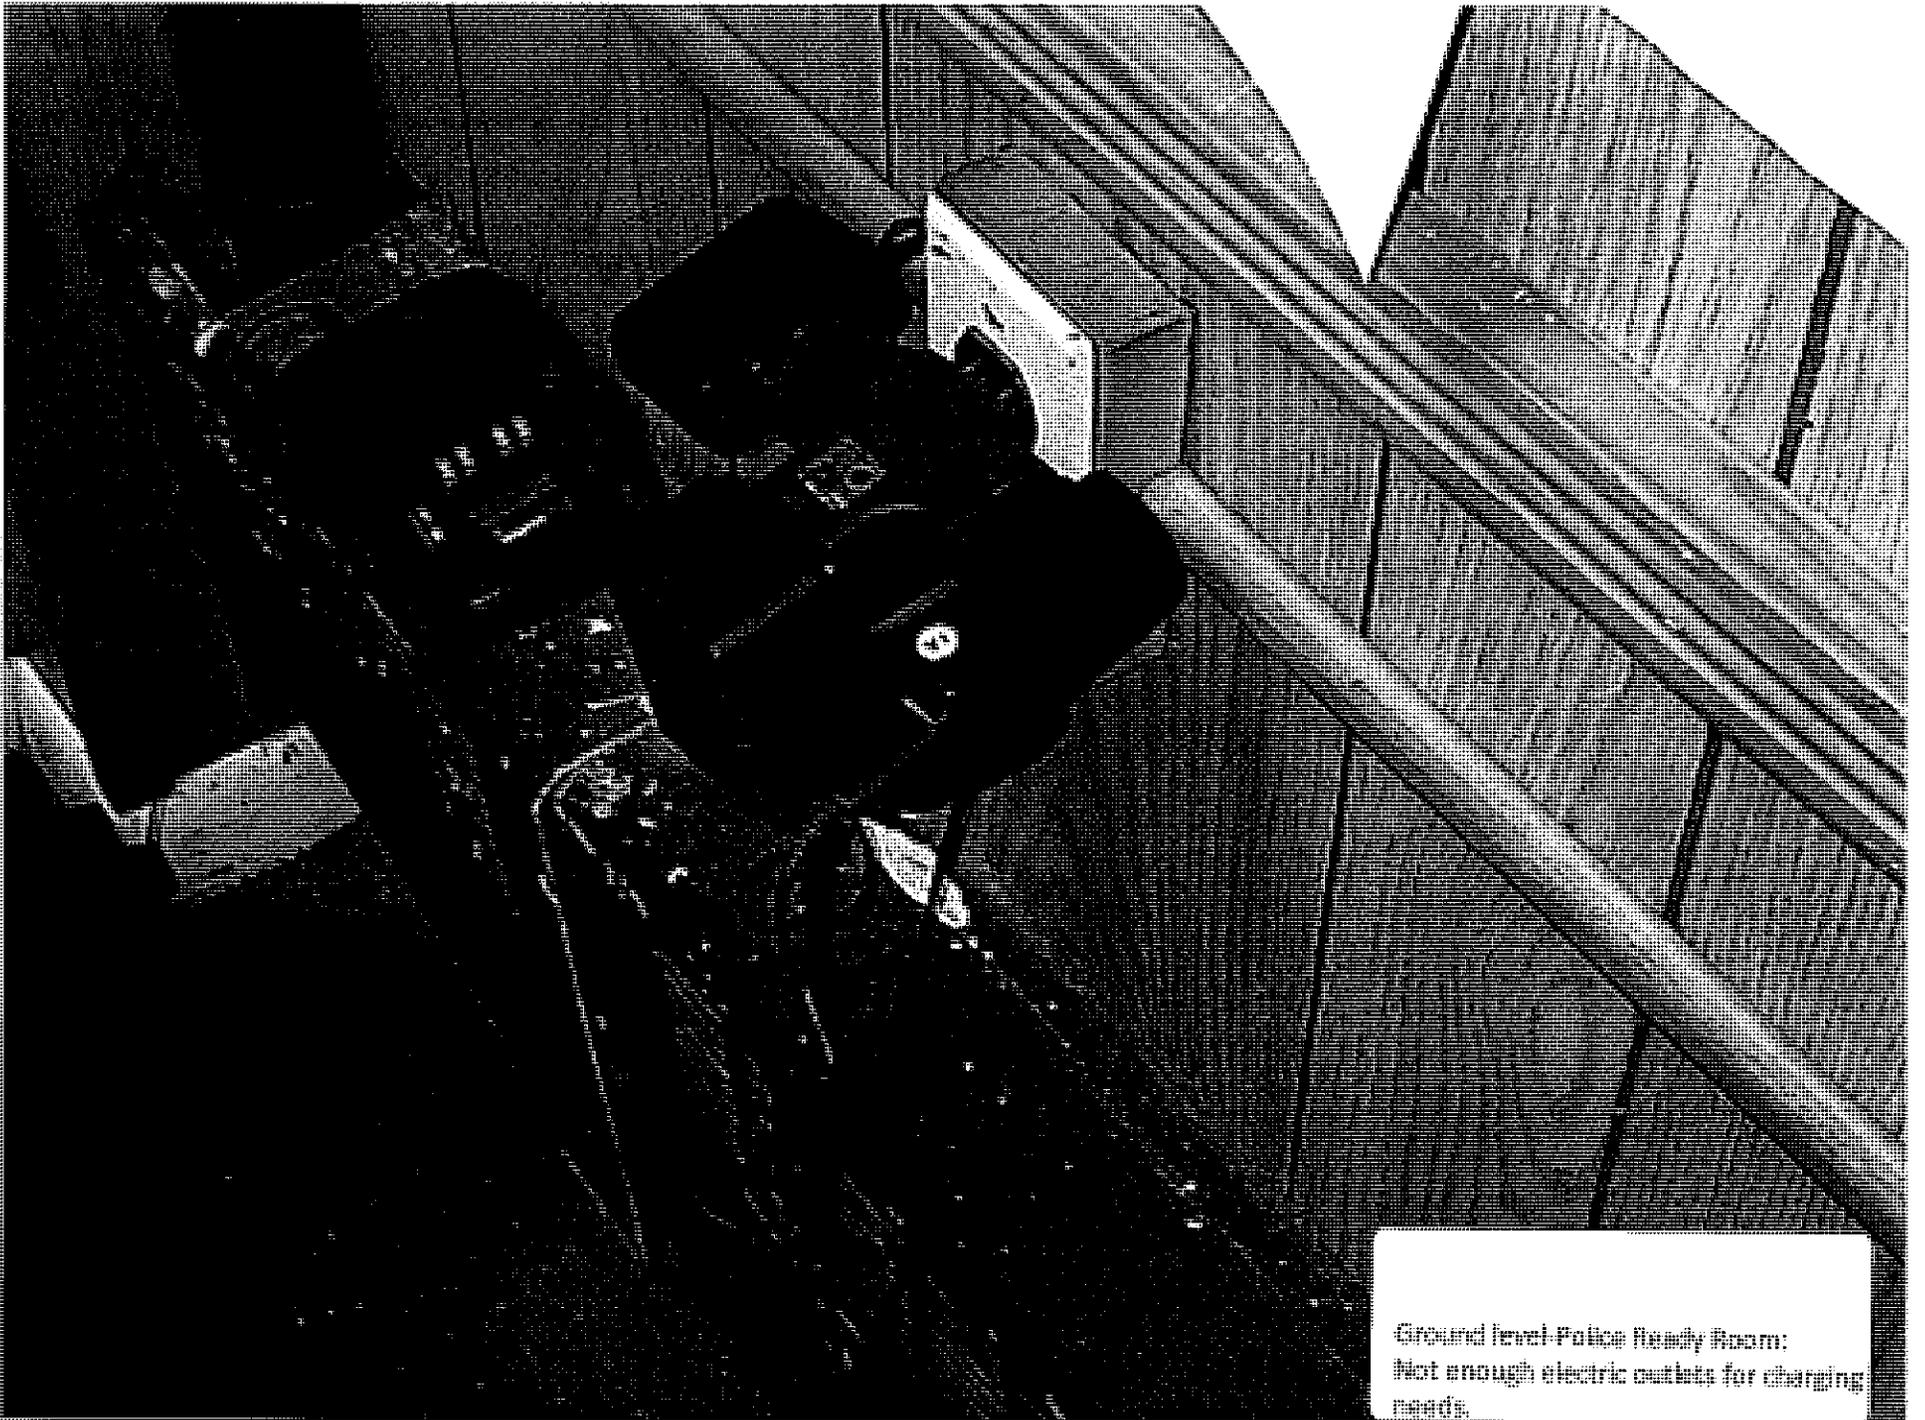
Ground level Police Ready Room:  
Not enough electric outlets for charging  
needs.

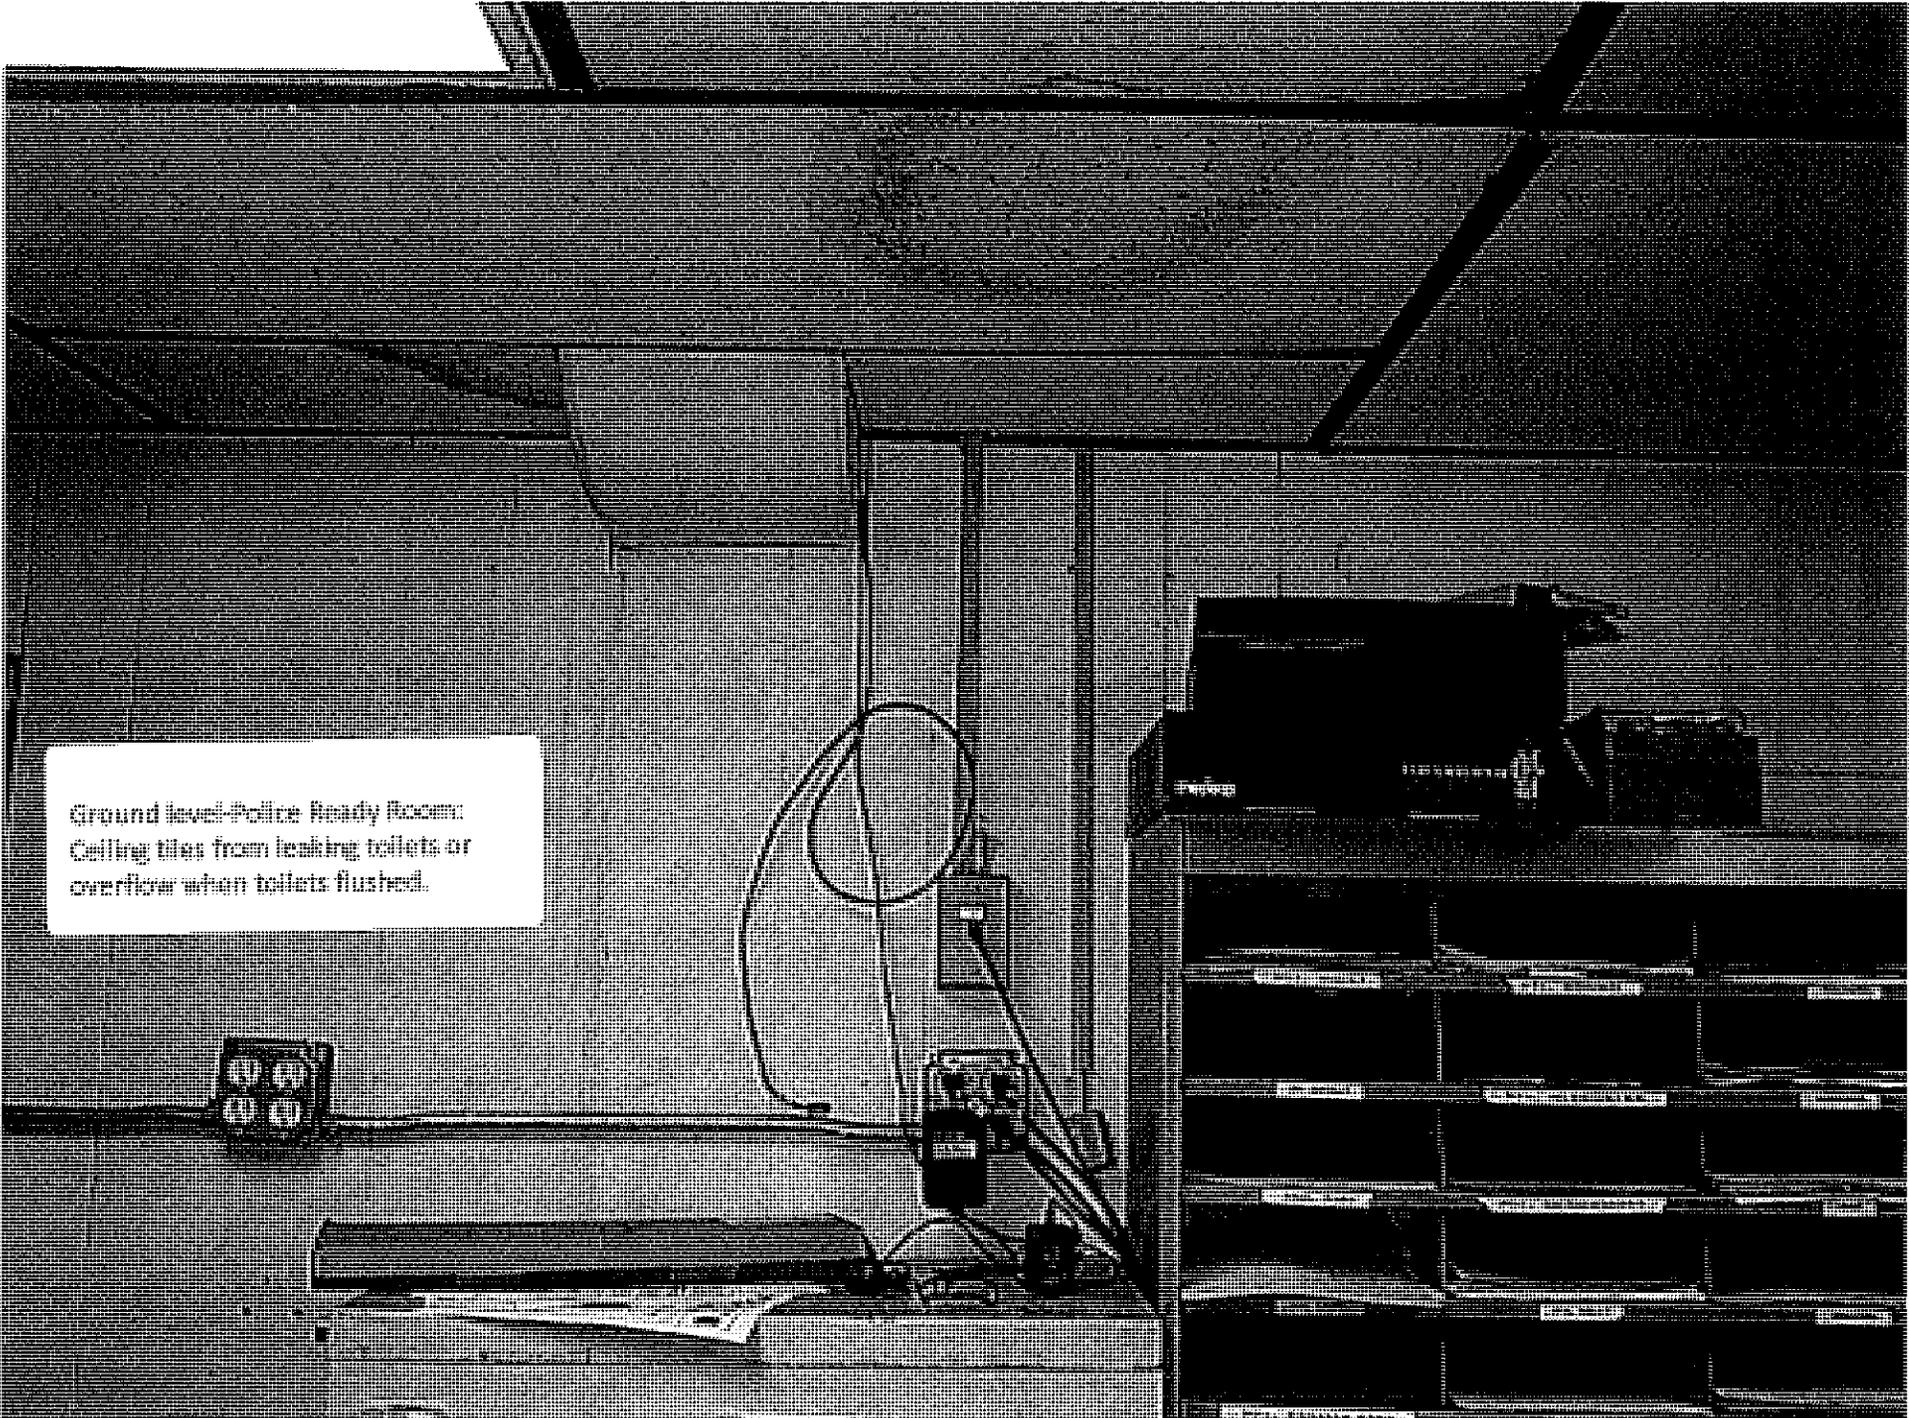
Ground level-Police Ready Room:  
Ceiling tiles from leaking toilets or  
overflow when toilets flushed.

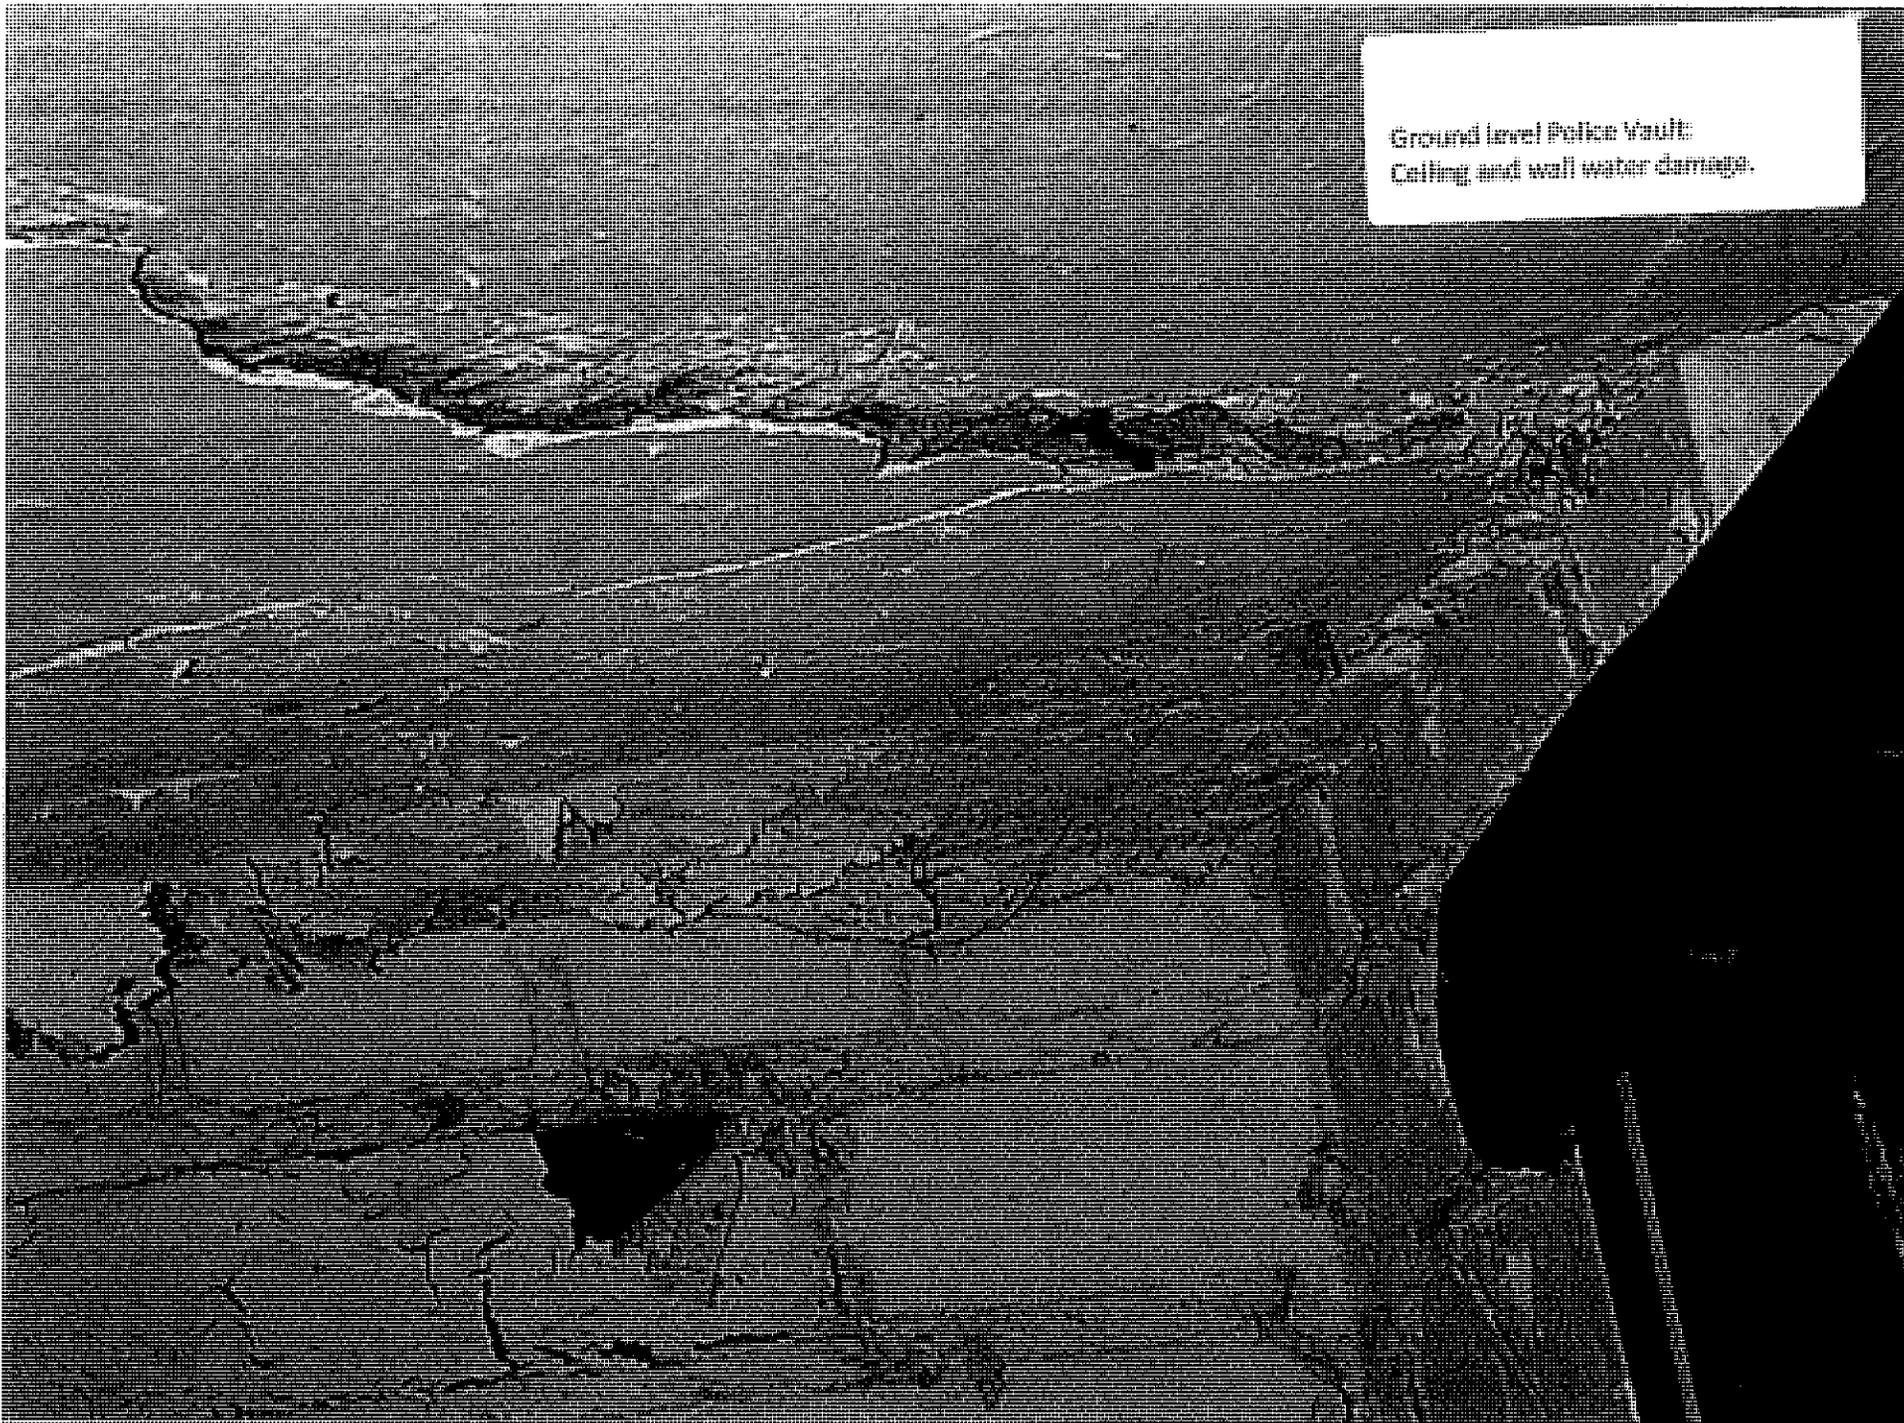
Ground level Police Vault:  
Ceiling and wall water damage.

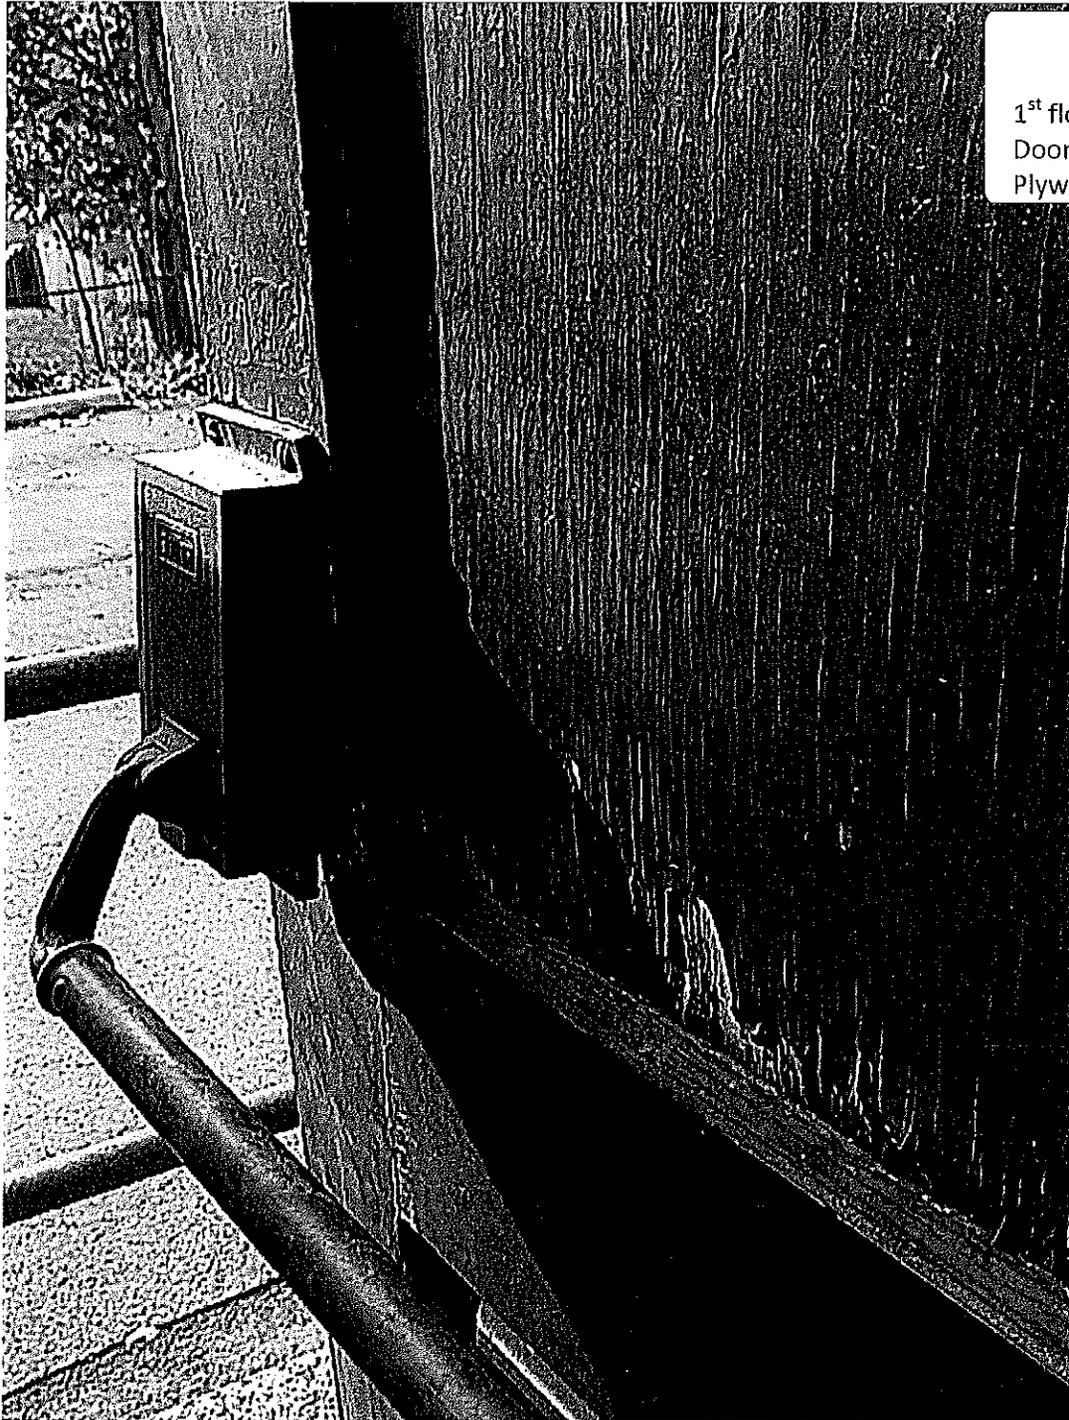
1<sup>st</sup> floor Emergency Exit:  
Door frame and door rotted away.  
Plywood over door on outside.

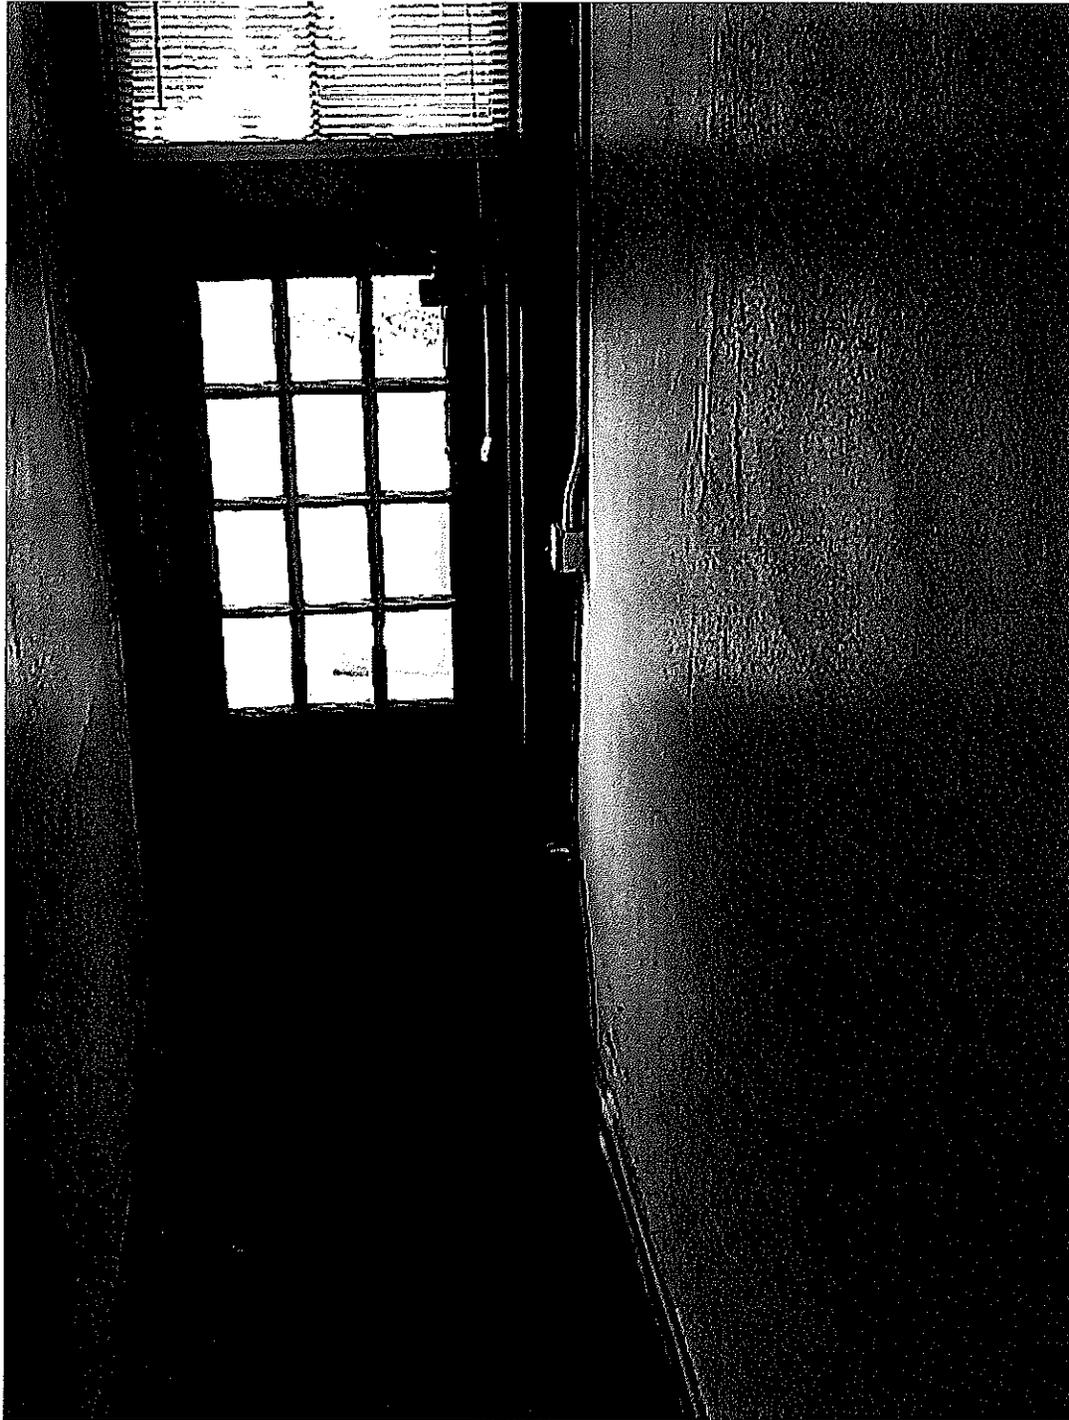
1<sup>st</sup> floor Emergency Exit:  
Door and door frame beyond repair,  
does not lock.

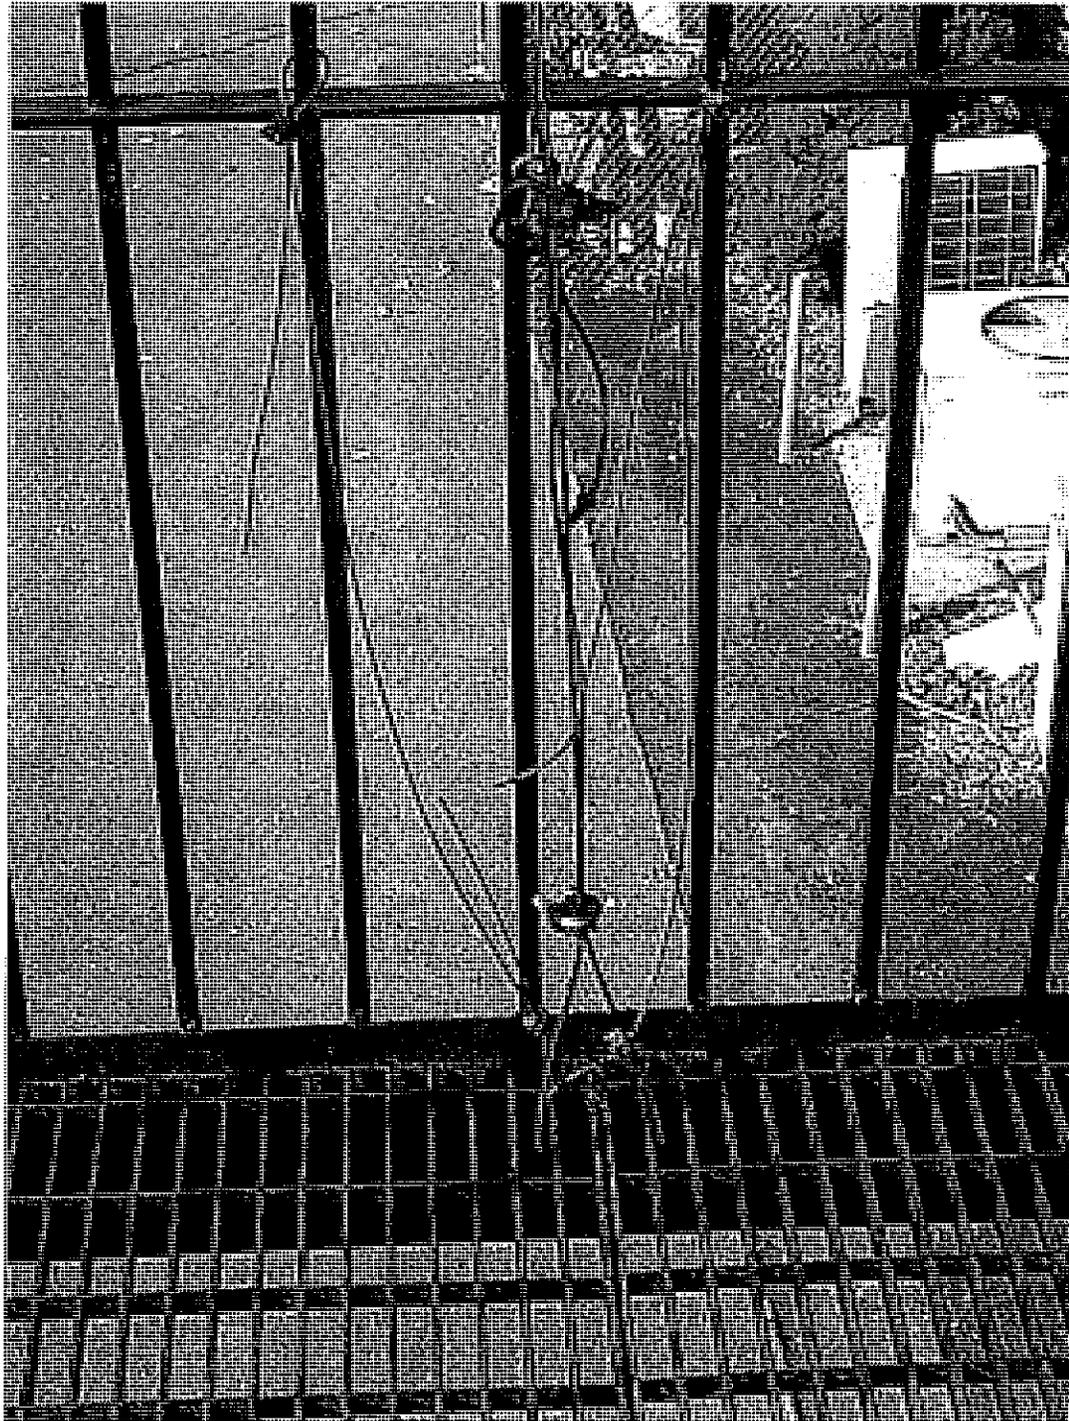
2<sup>nd</sup> floor Fire Escape:  
Landing fell-repaired by welding.  
Cables attached for a little extra  
Safety.

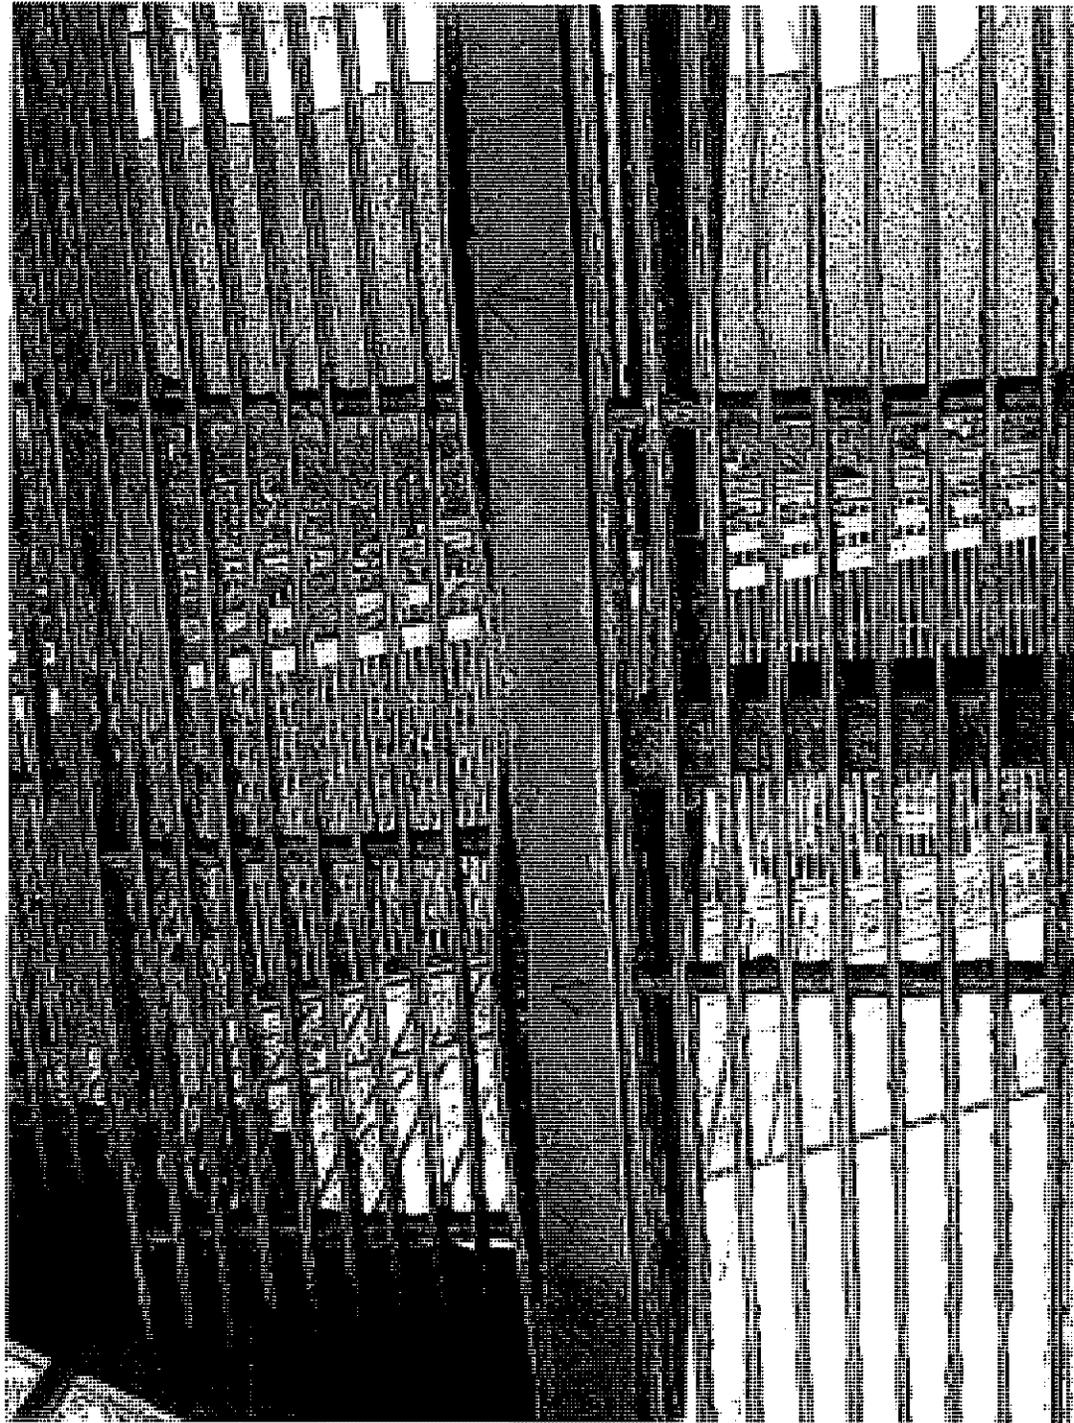
Fire escape stairs rusting away-treads separating from the frame.

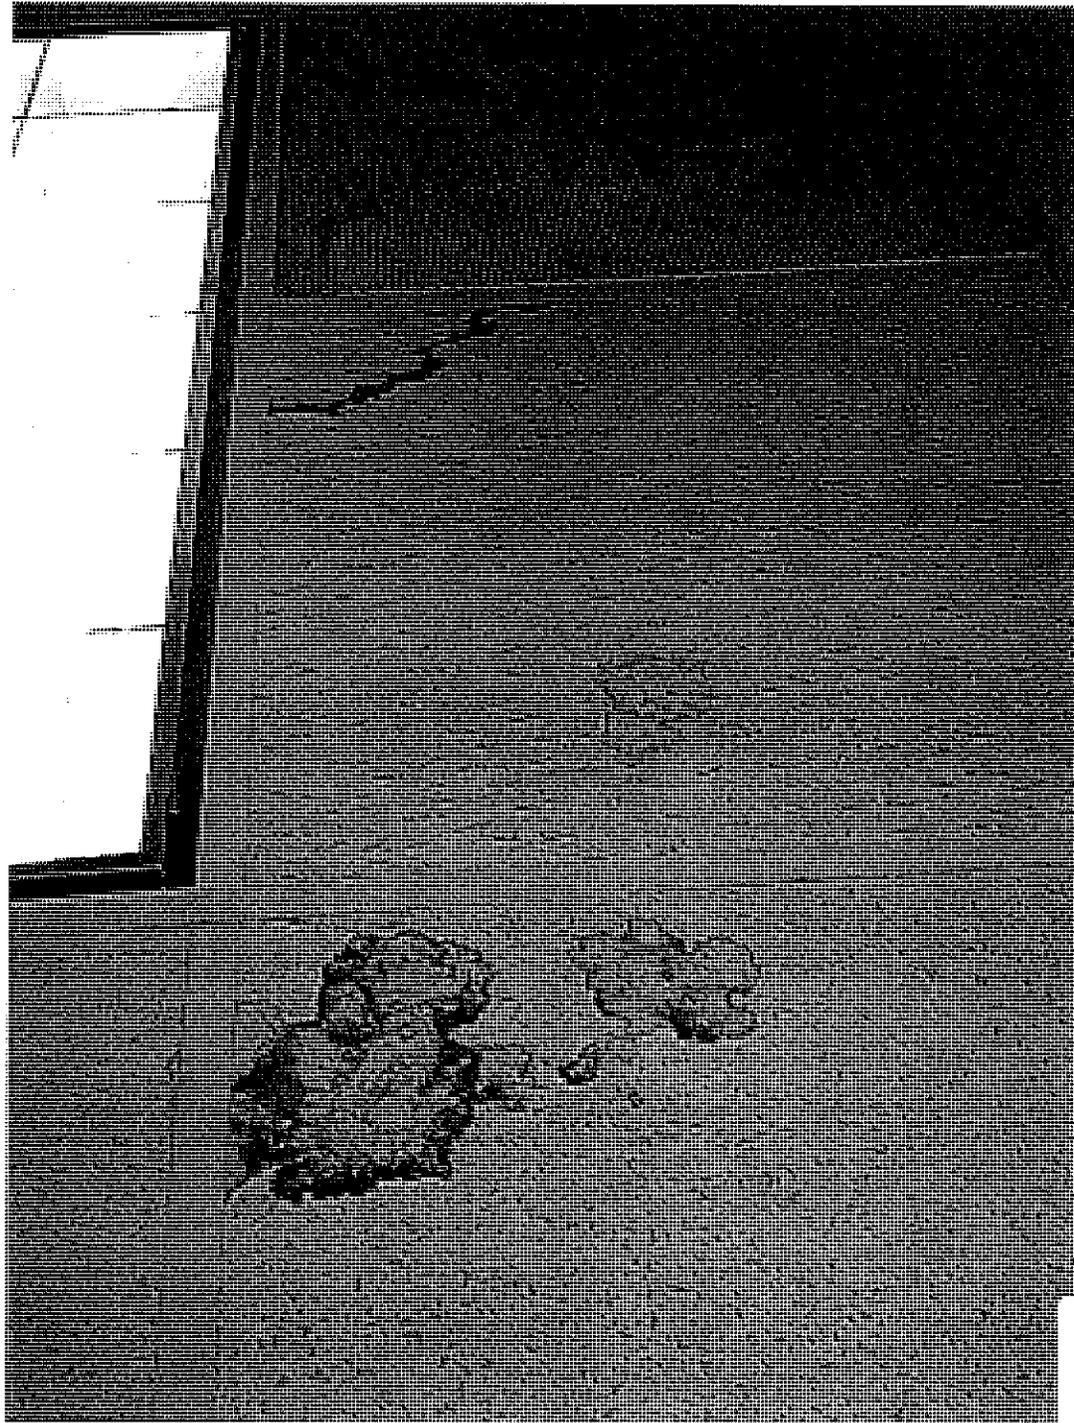
2<sup>nd</sup> floor ceiling tile water damage.

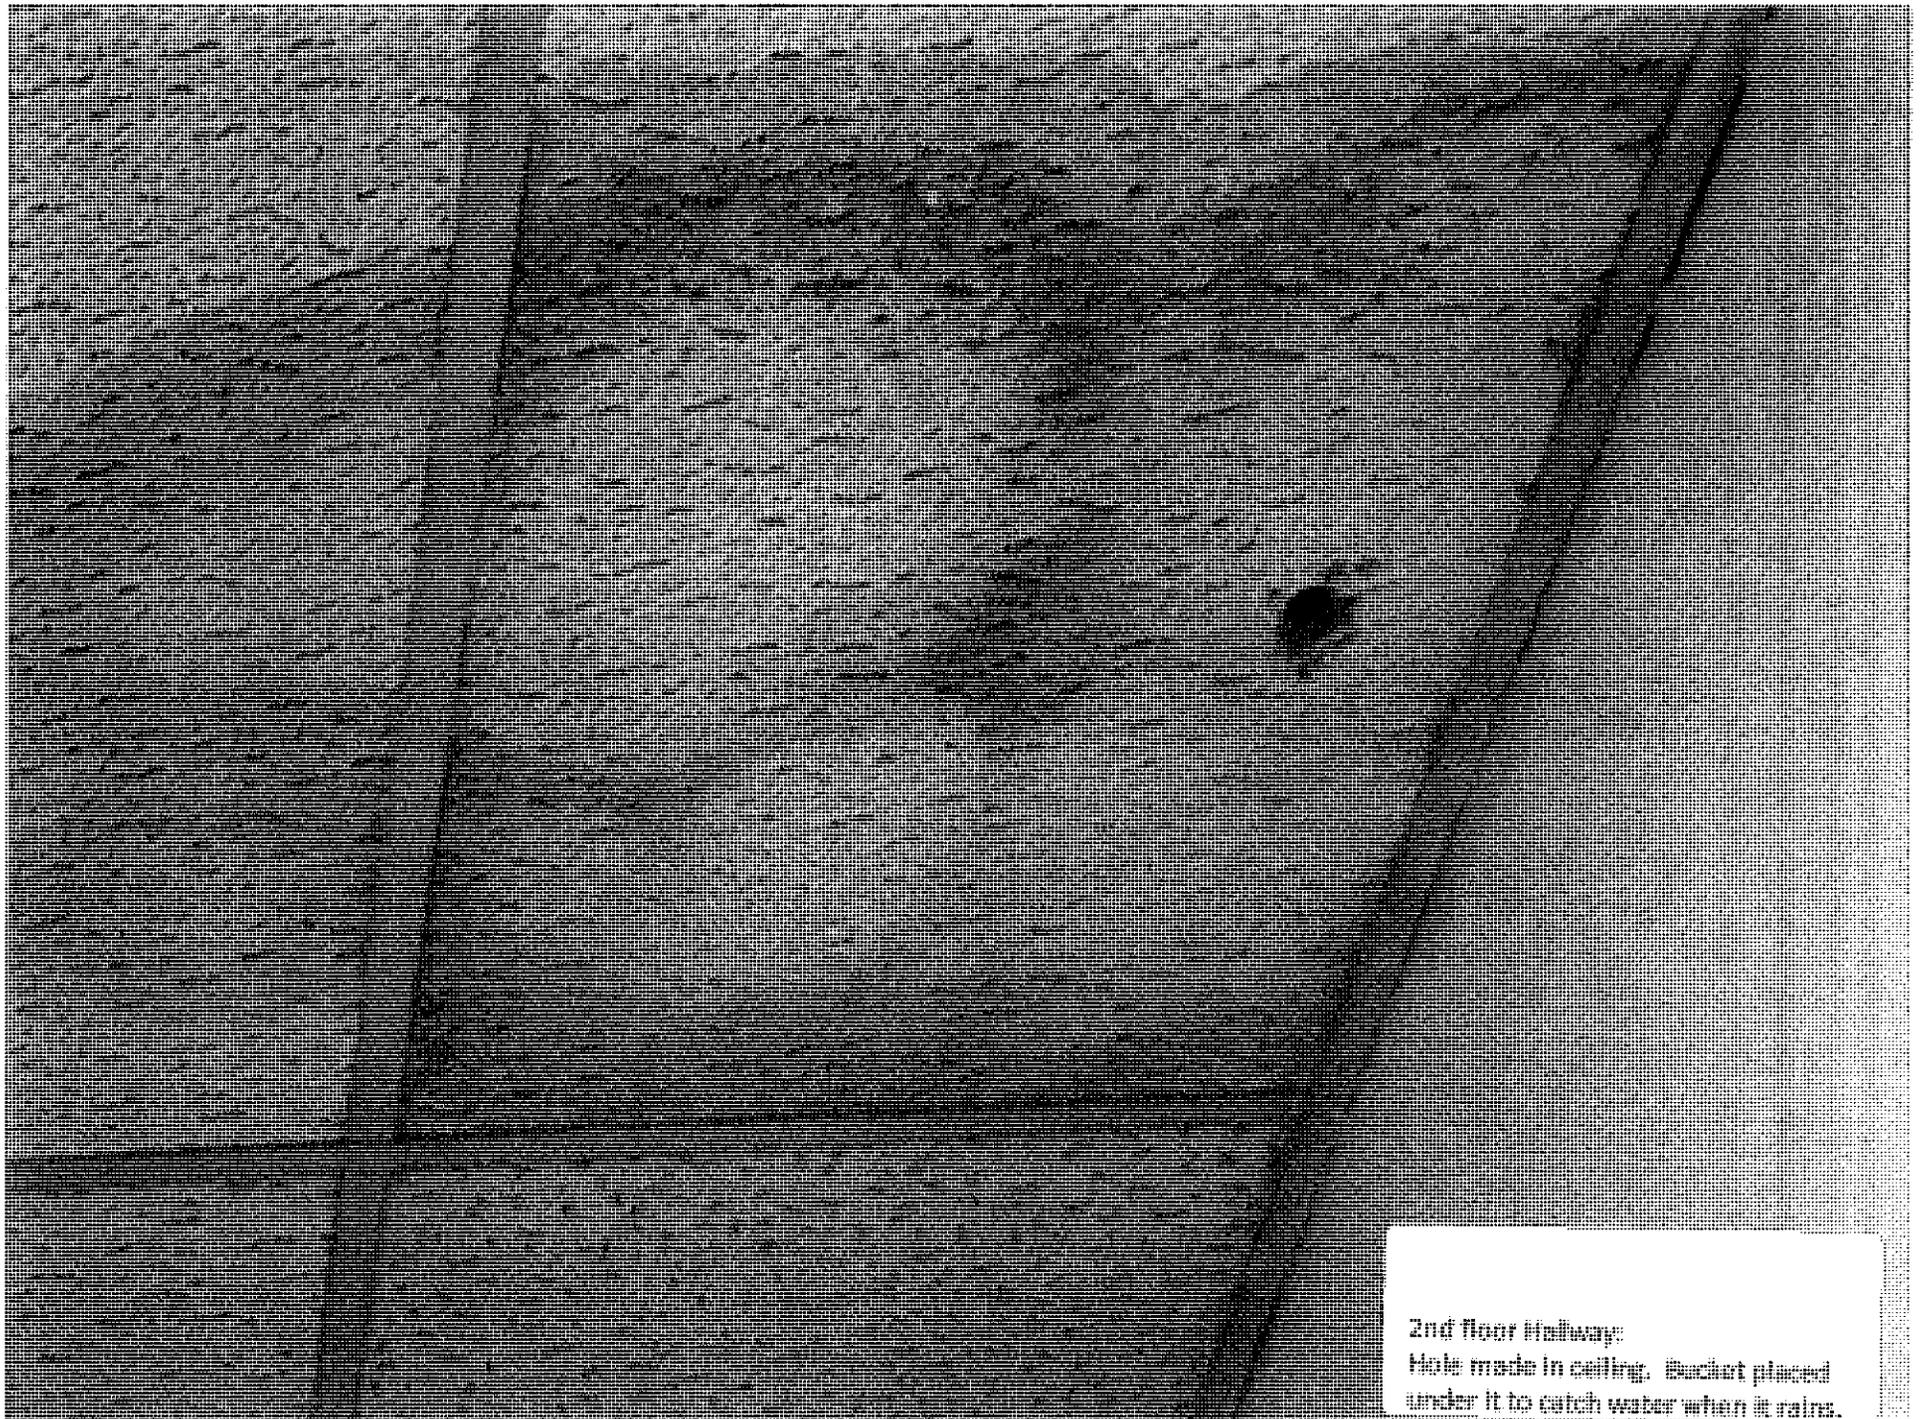
2nd floor hallway:  
Hole made in ceiling. Bucket placed  
under it to catch water when it rains.

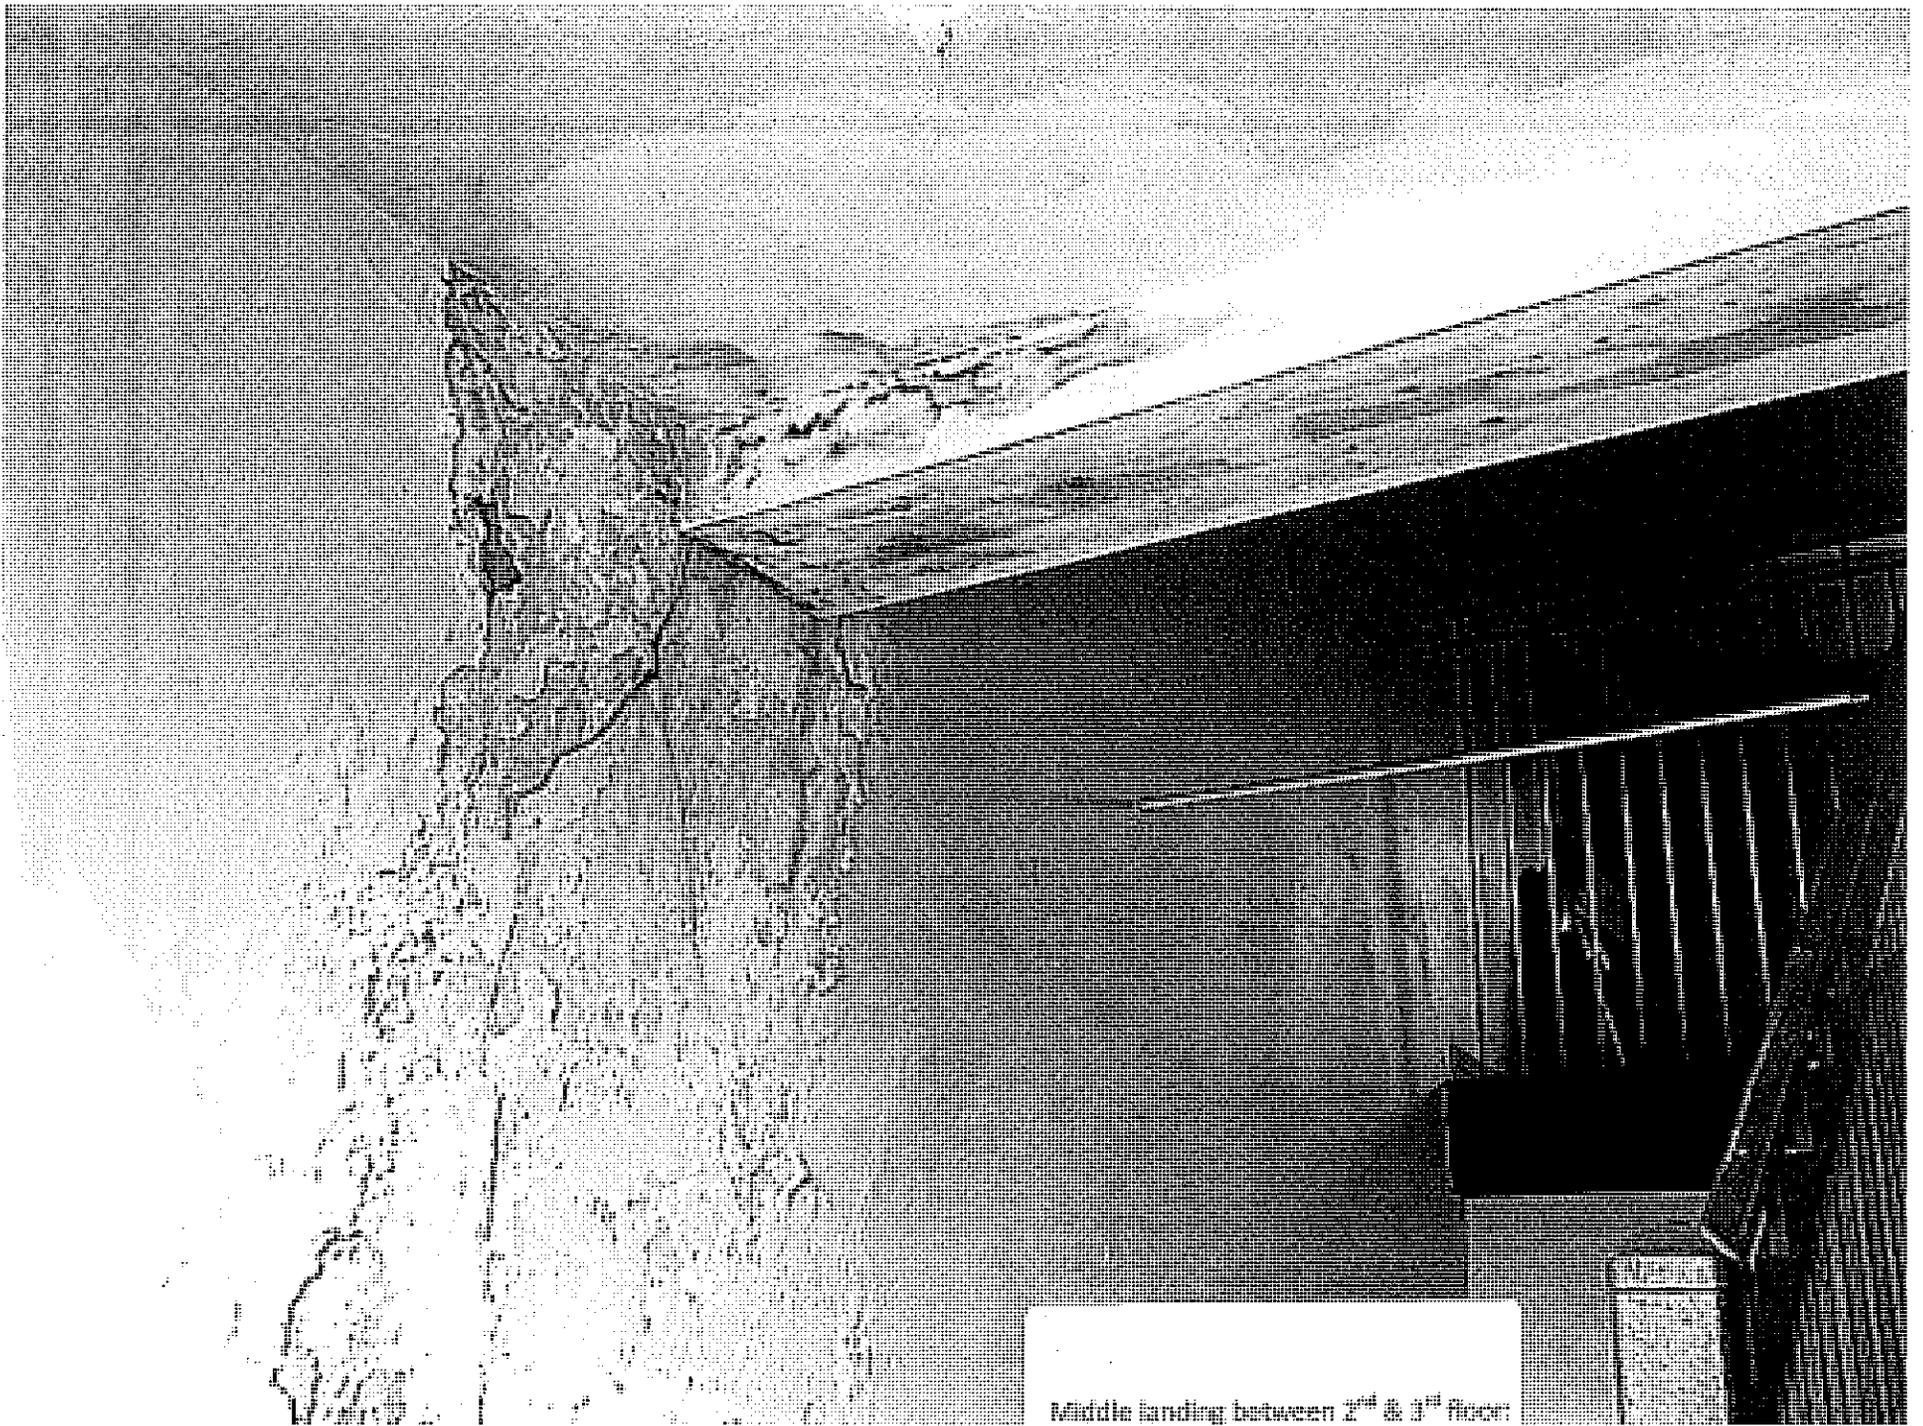
Middle landing between 2<sup>nd</sup> & 3<sup>rd</sup> floor  
Wall not repairable and mold damage

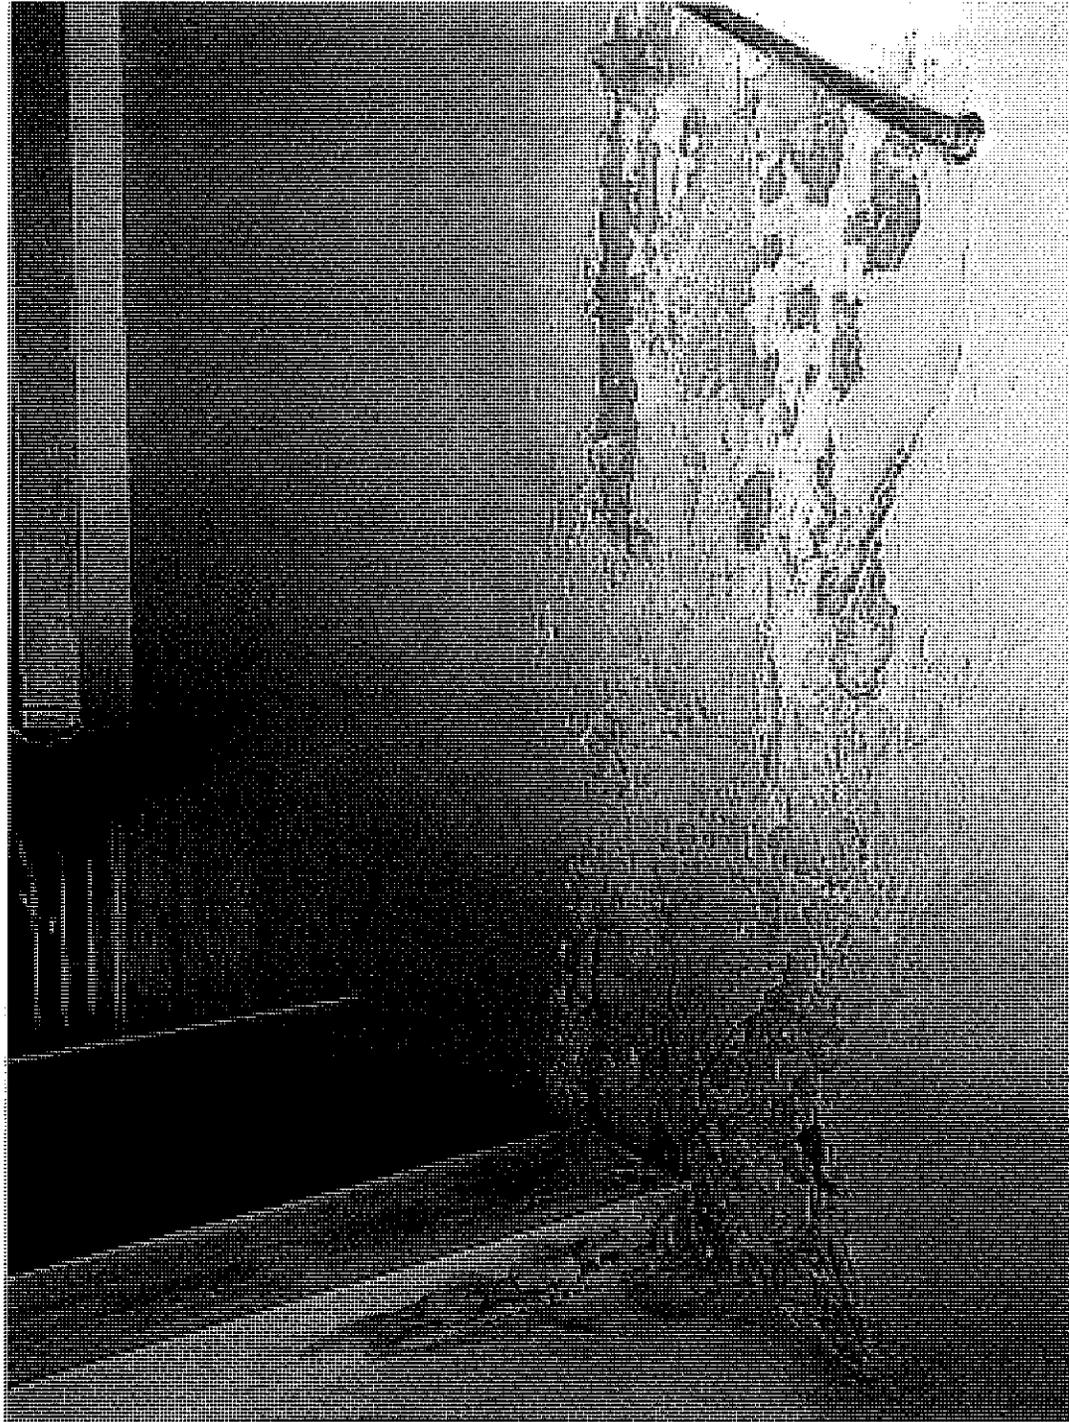
Middle landing between 2<sup>nd</sup> & 3<sup>rd</sup> floor:  
Water and mold damage
