An industrial hygiene investigation was conducted on July 7, 23, and 30, 2014 by the Bergen County Department of Health Services at the following facility:

**Dumont Borough Hall**  
**50 Washington Avenue**  
**Dumont, NJ 07628**

## DUMONT BOROUGH HALL

Prepared By: County of Bergen  
Department of Health Services  
Melissa Johnson, MS, Industrial Hygienist

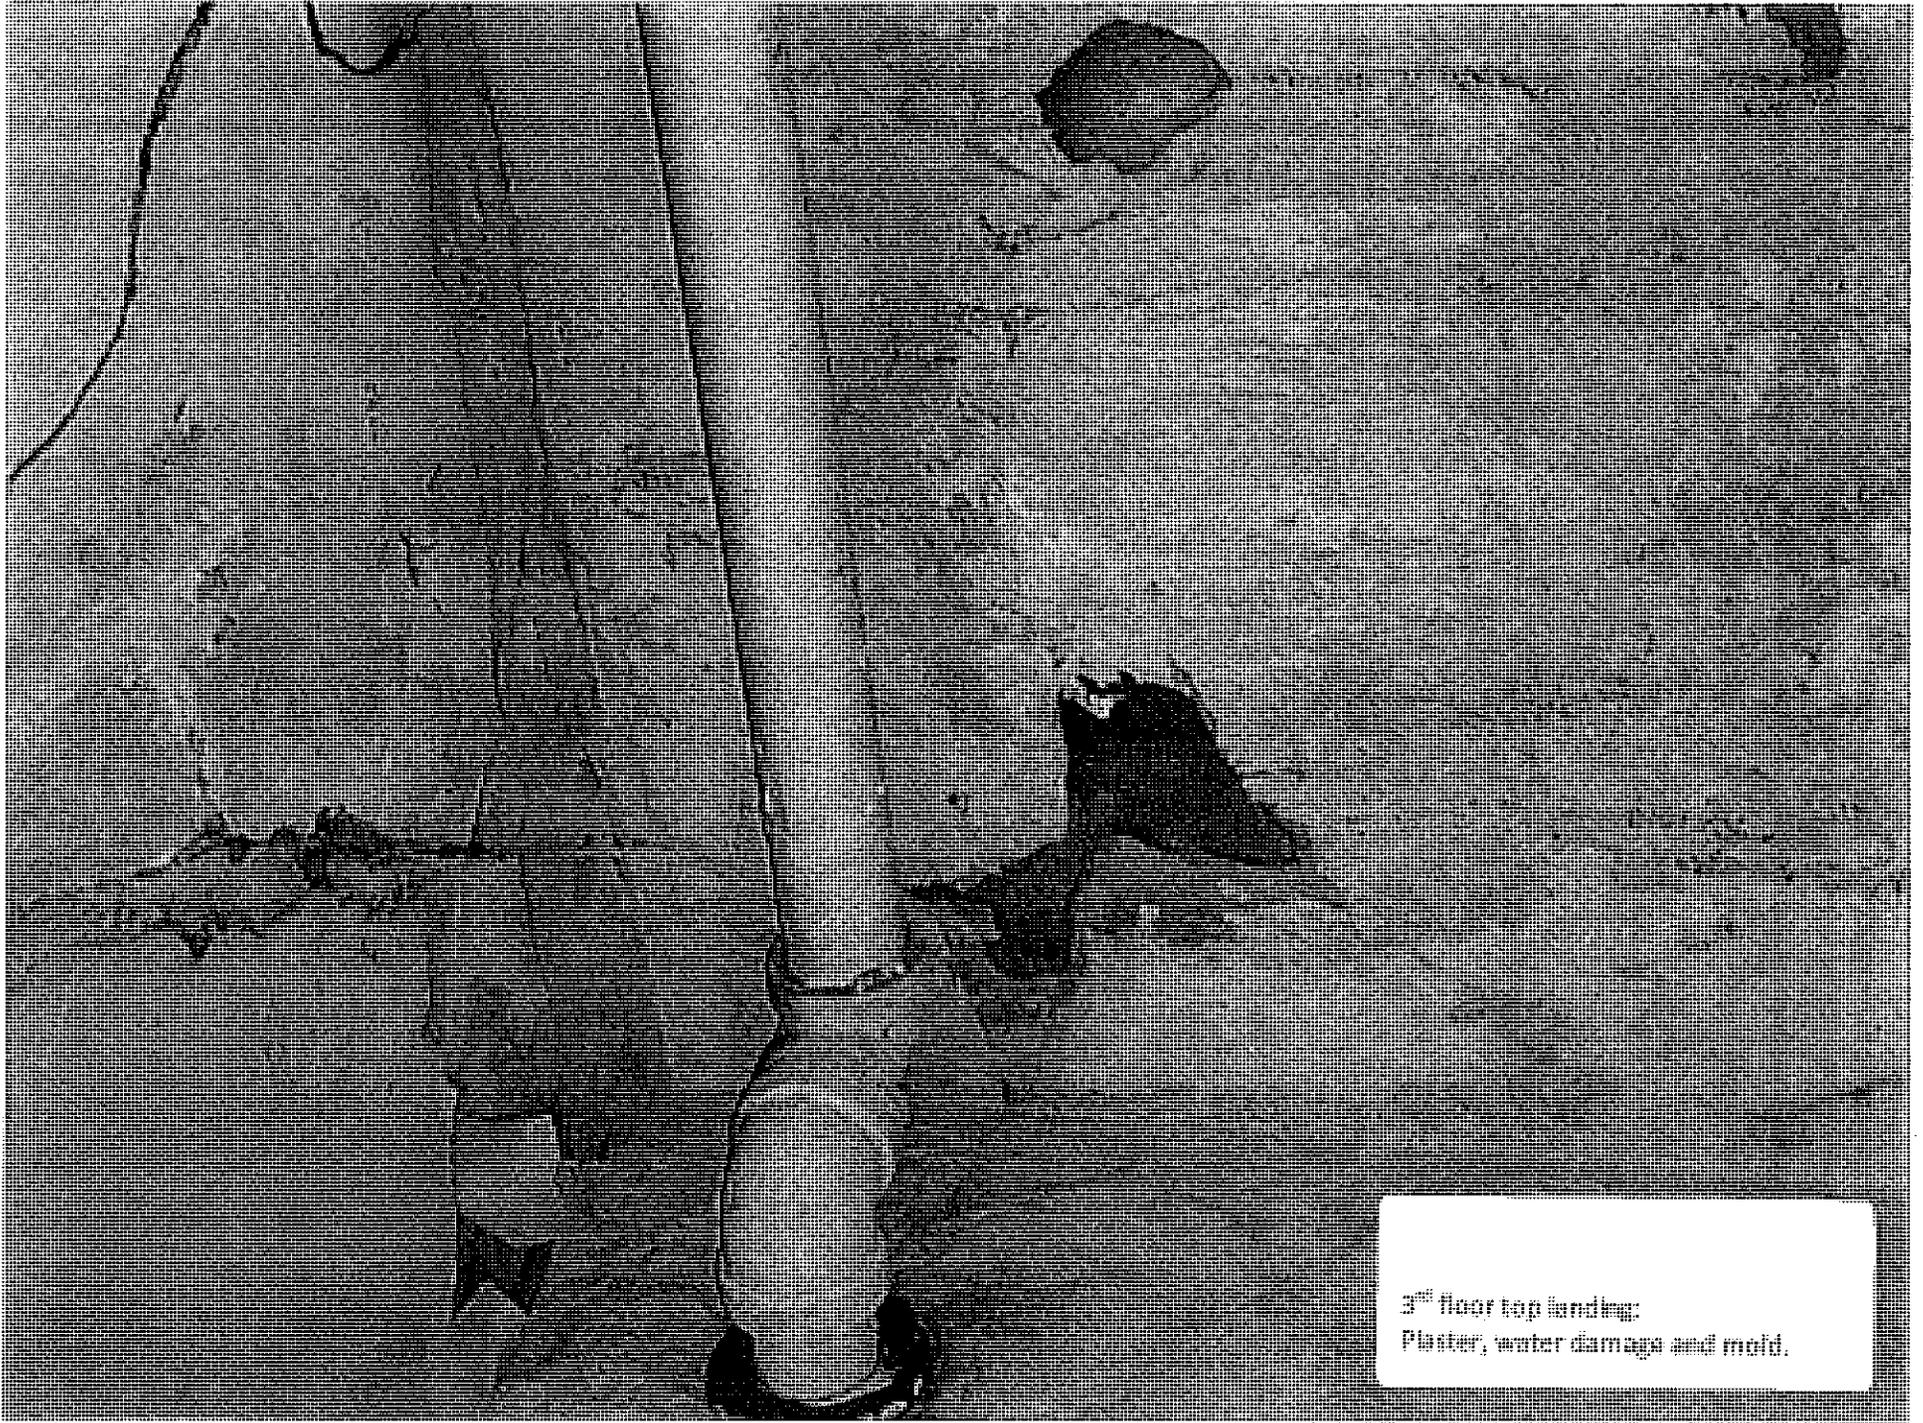
3<sup>rd</sup> floor top landing:  
Plaster, water damage and mold.

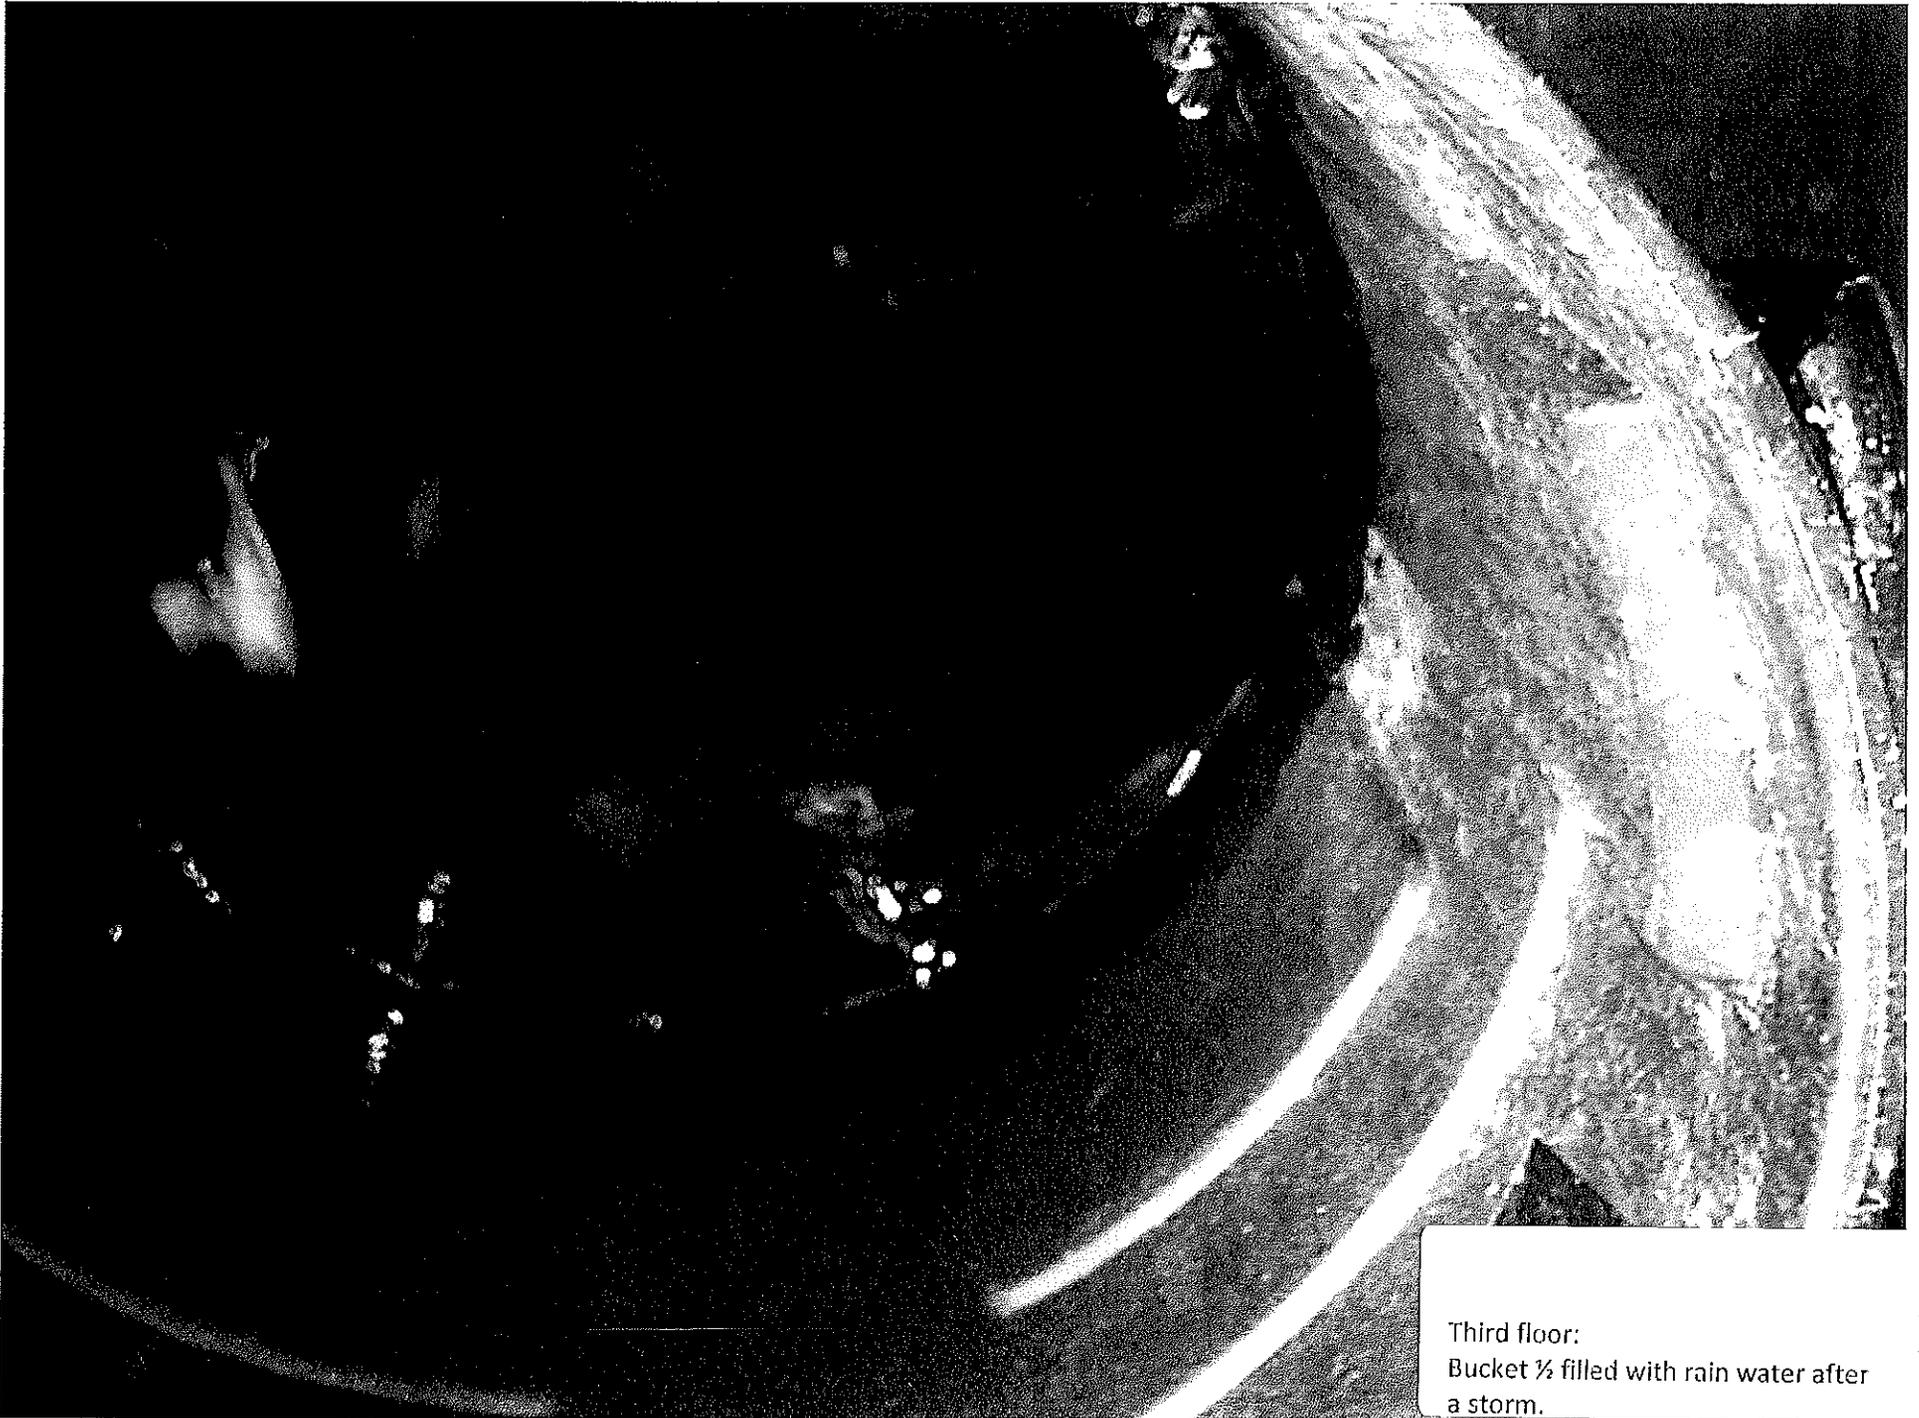
Third floor:  
Bucket  $\frac{1}{2}$  filled with rain water after  
a storm.

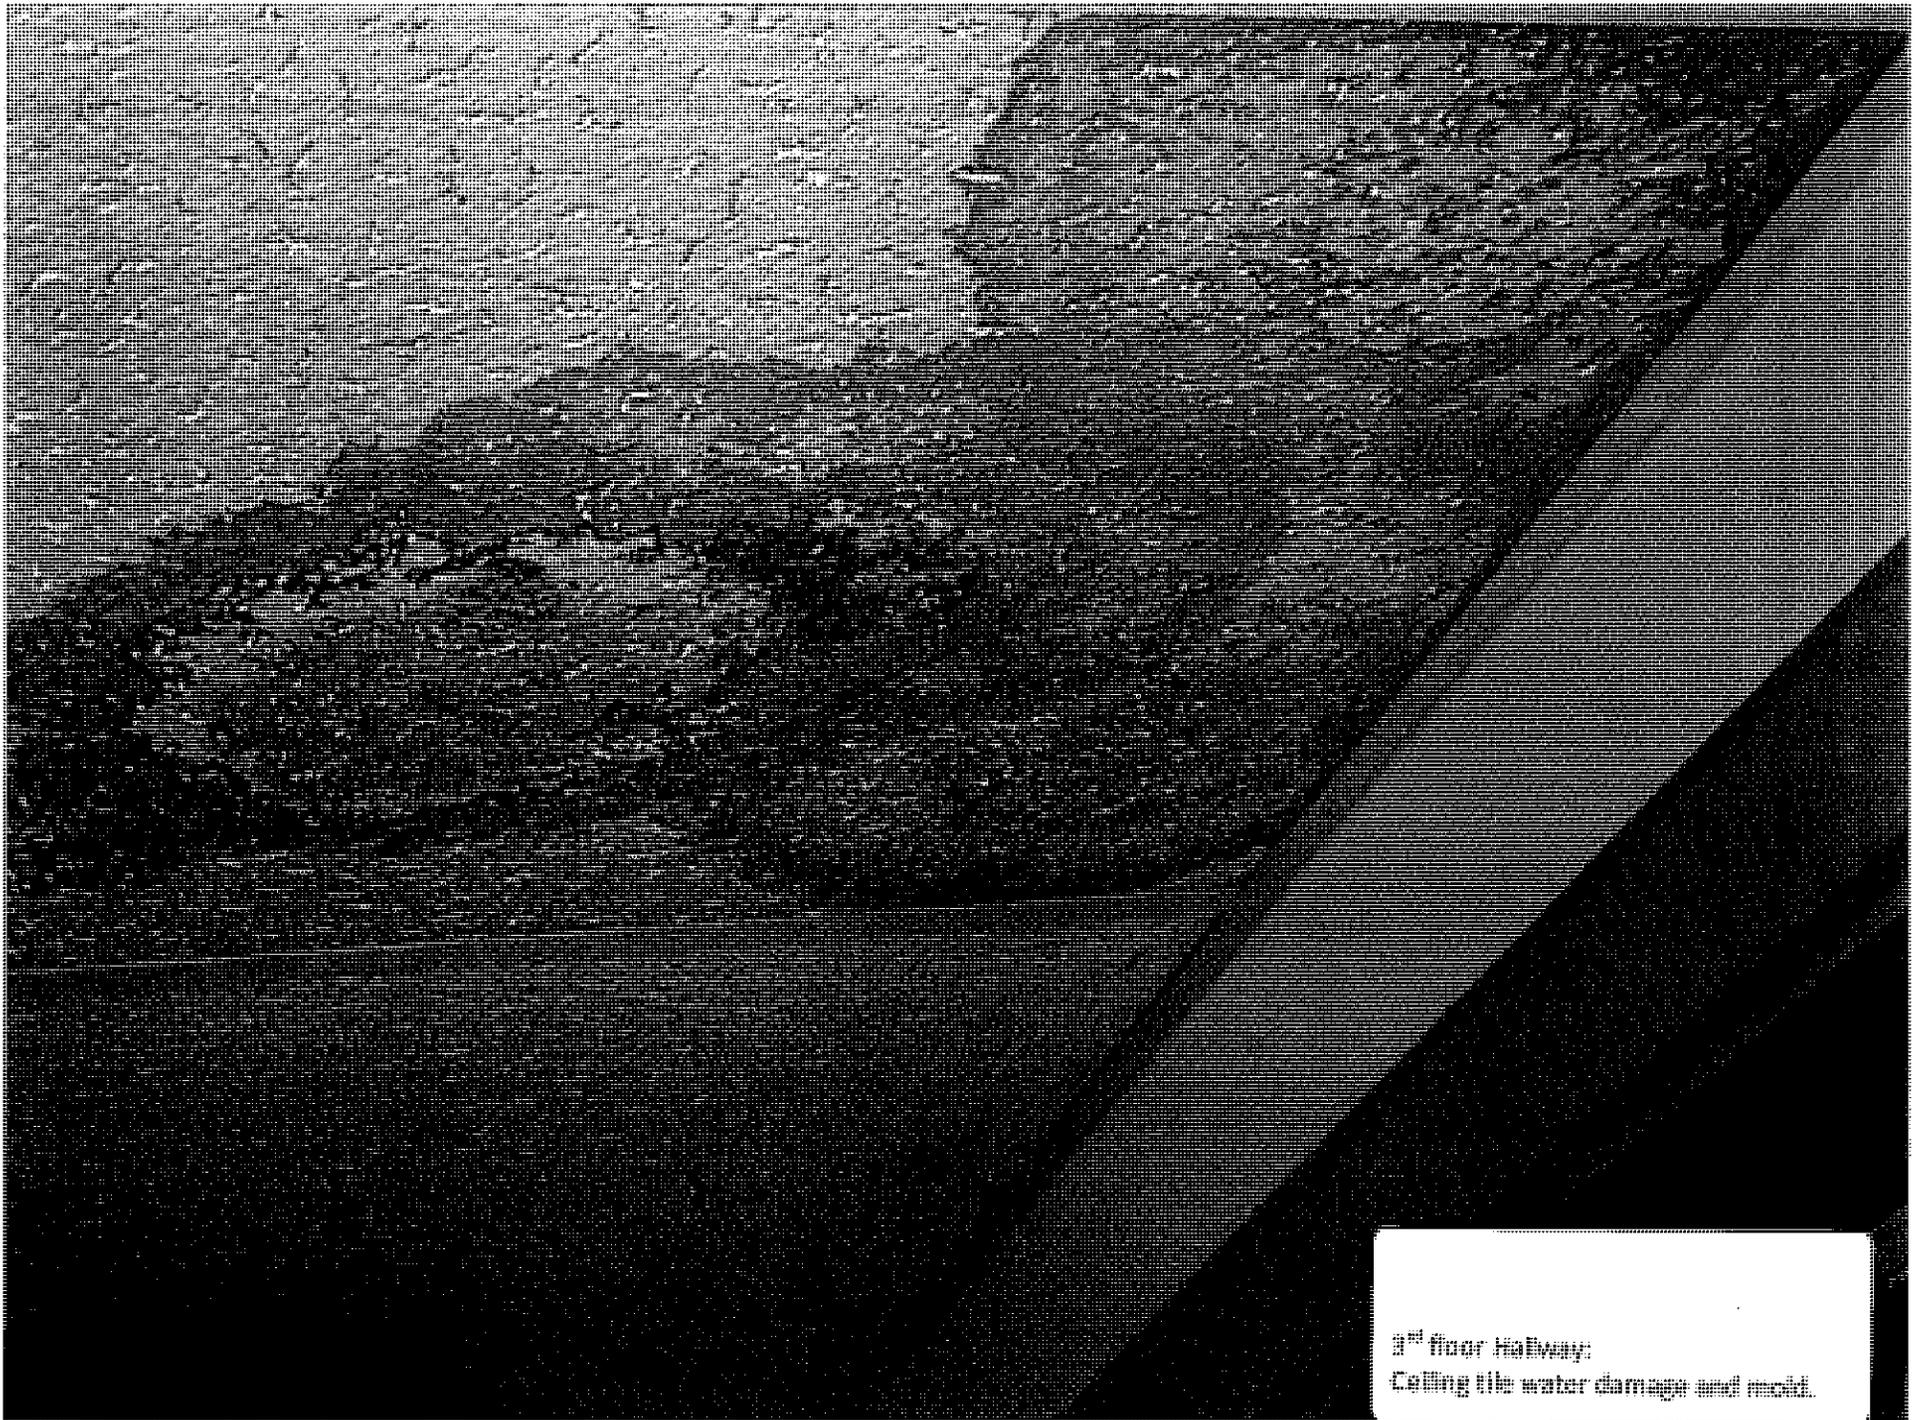
3<sup>rd</sup> floor Hallway:  
Ceiling tile water damage and mold.

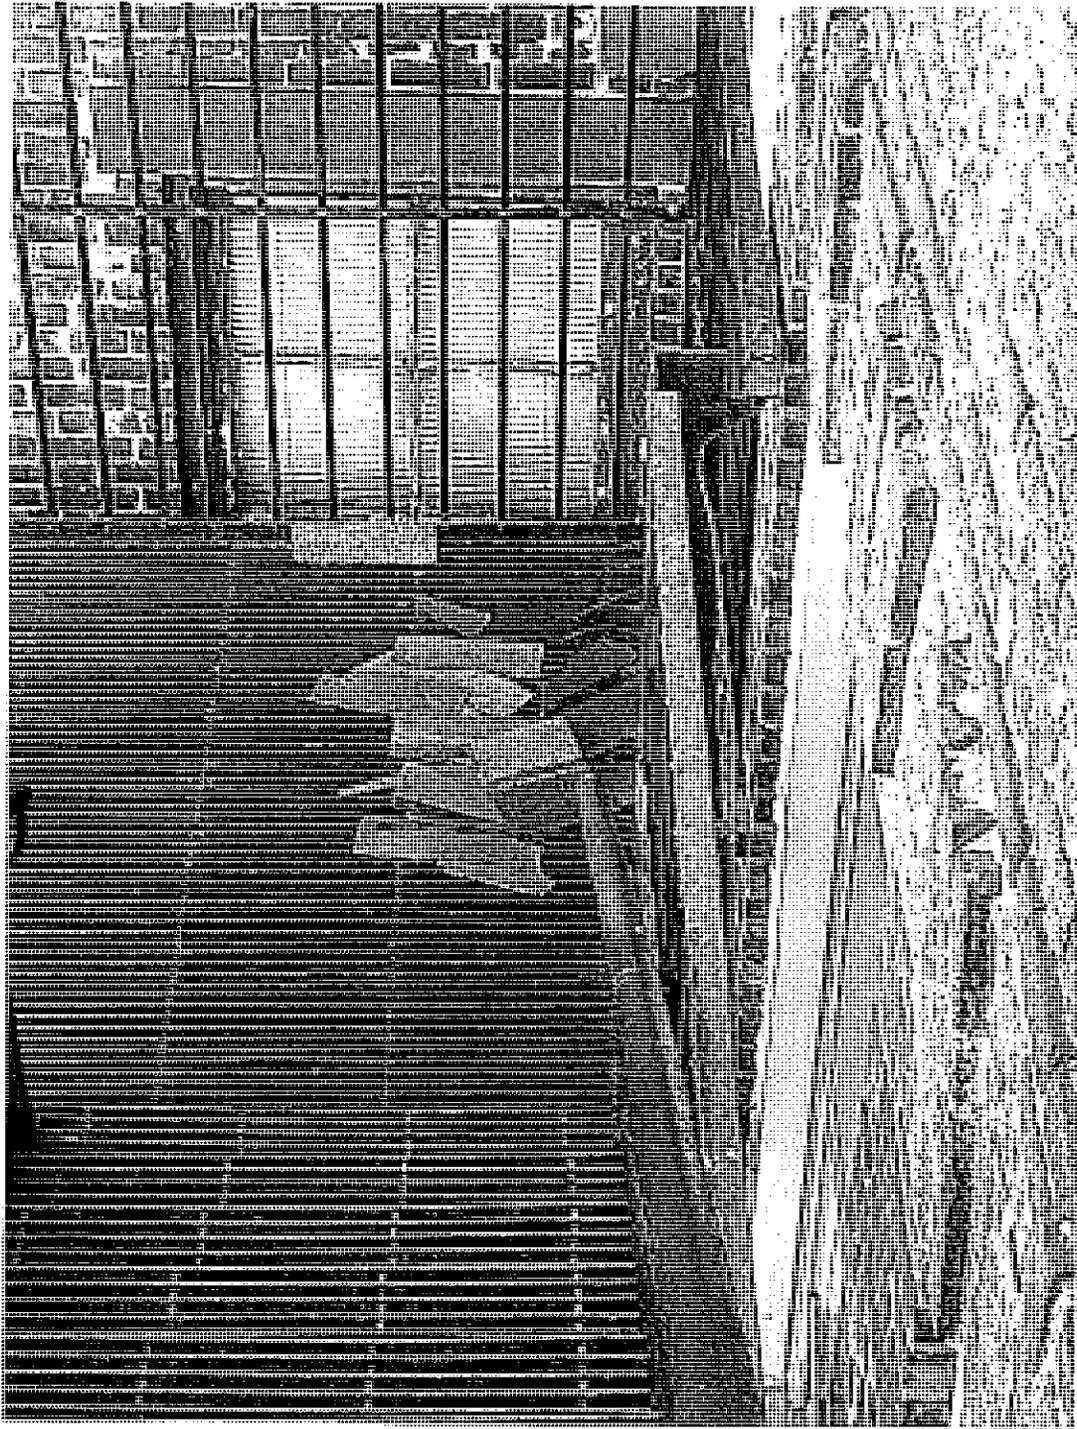
Fire escape:  
Roof shingles falling off roof.

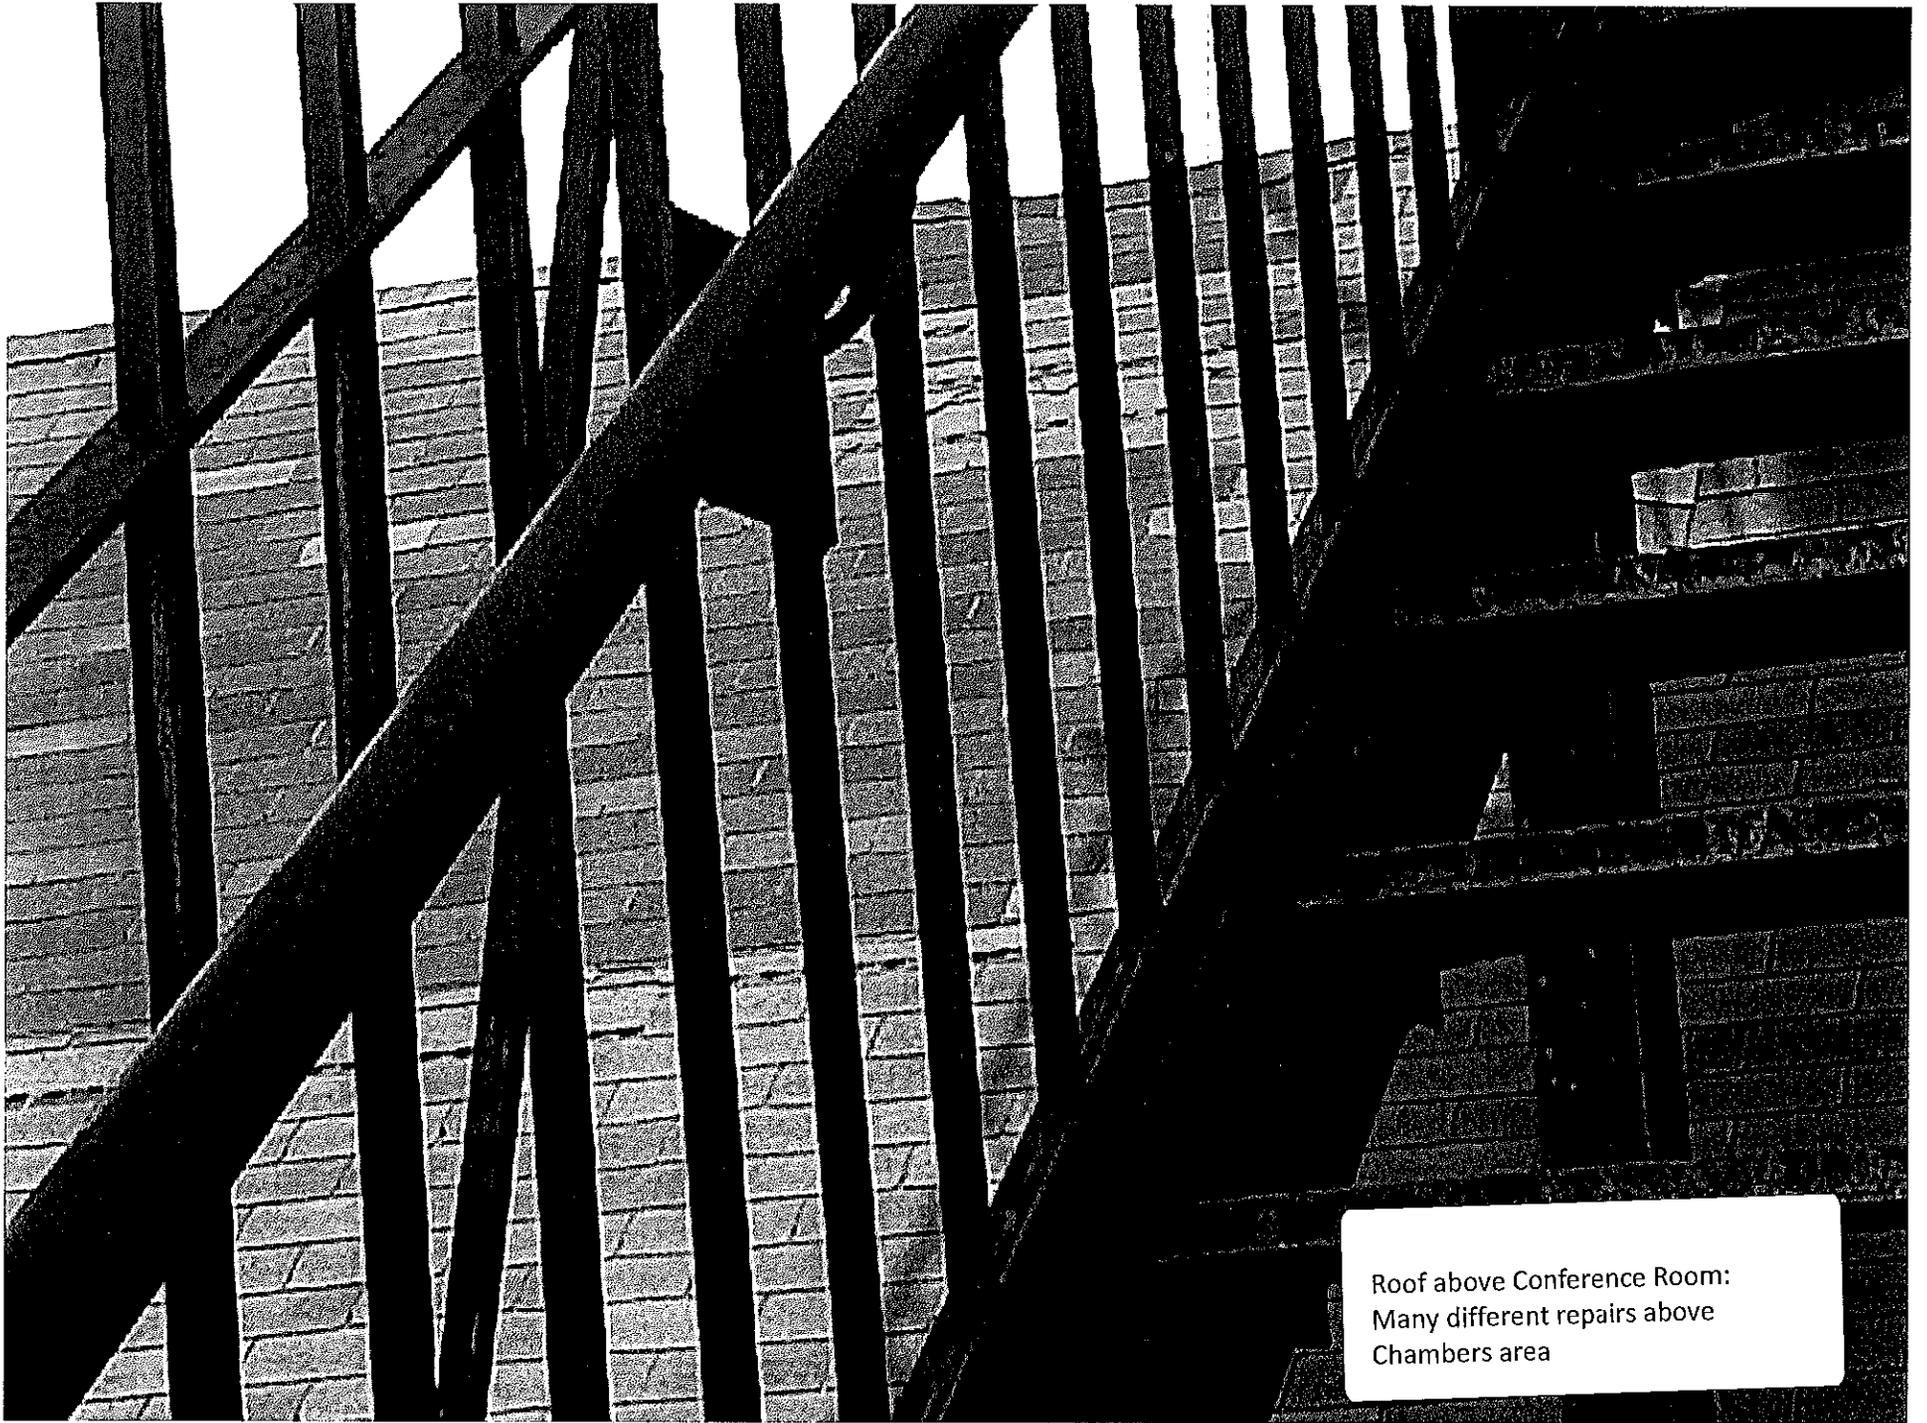
Roof above Conference Room:  
Many different repairs above  
Chambers area
